Multi-Family Building Energy Audit

Property Management, Inc.

City Senior Tower
456 Central Ave.
Metropolis, PA 12345

February 3, 2011

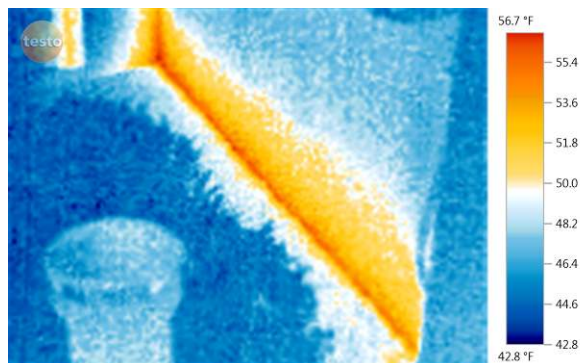
Thermal imaging shows significant heat loss at the first floor slab, indicating that no slab insulation is present. (Note the warm yellow/orange streak where the slab meets the landscaping.)

No changes are recommended.

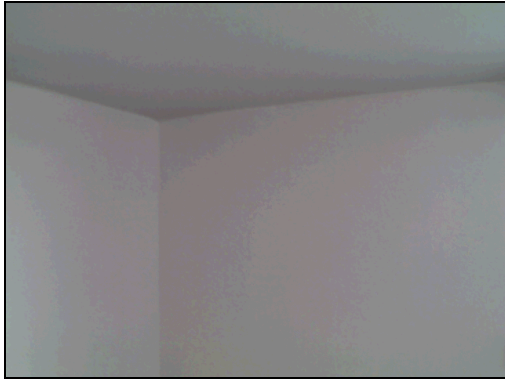
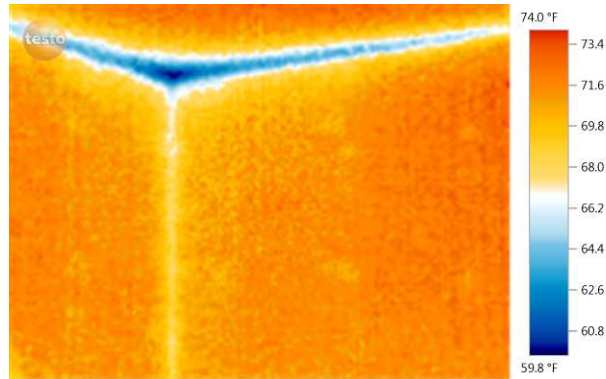
The manager noted that, during maintenance tasks, rigid insulation has been found between steel studs and the exterior concrete wall panels. This was verified during visual inspection in one apartment. Thermal imaging also confirms the presence of this insulation. The steel studs are visible as the coldest areas. The cavities between them are clearly insulated because they are warmer.

Thermal imaging on the exterior shows significant heat loss through the edges of the slabs where they protrude between the wall panels at each floor. This is also visible at the ceiling/wall junction in the interior image above.

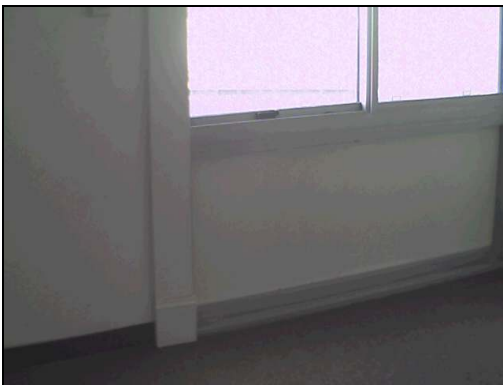
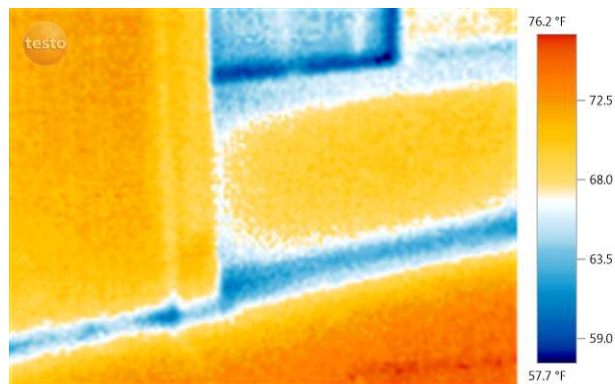
Solid panels are located below the windows in the apartments. These appear to be 0.75 – 1.0 inch thick with metal cladding. Thermal imaging indicates that they provide insulating value comparable to the adjacent walls.

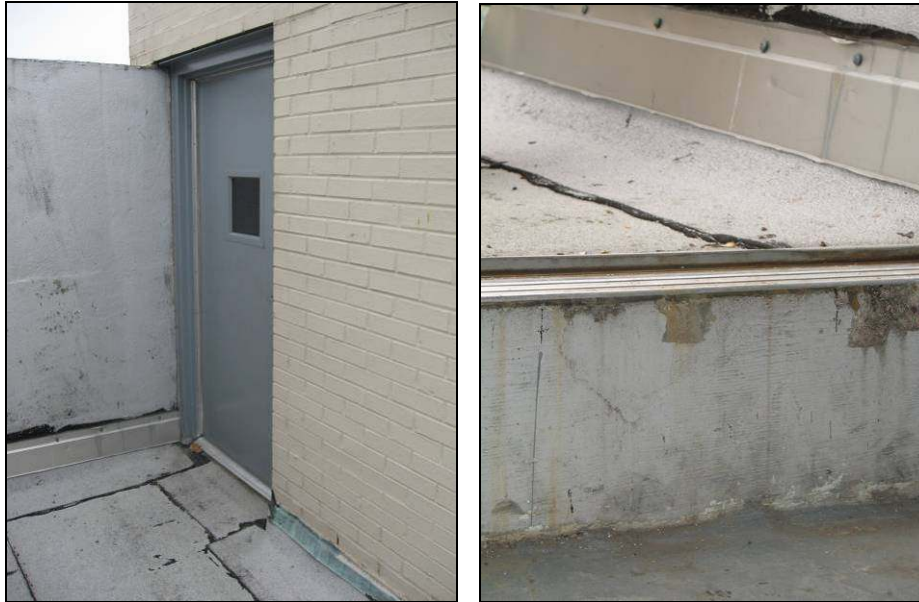
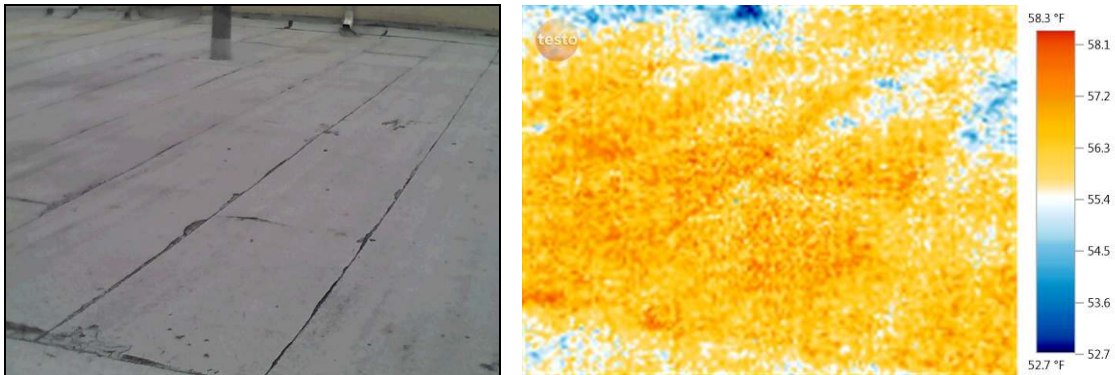
Based on visual inspection, it appears that a layer of rigid insulation was installed under the membrane when the roof was replaced. The roof membrane is 6+ inches higher than the exposed slab in the adjacent stairwell. In addition, thermal imaging shows little heat loss through the roof, supporting the conclusion that insulation is present.

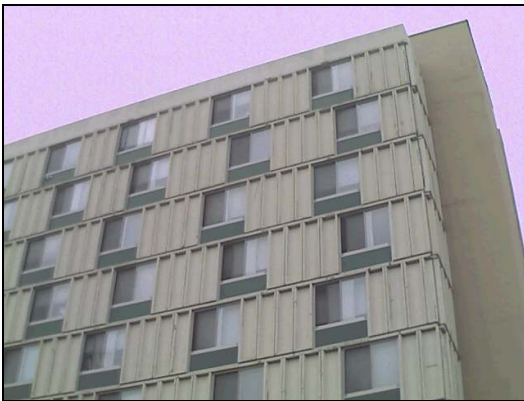
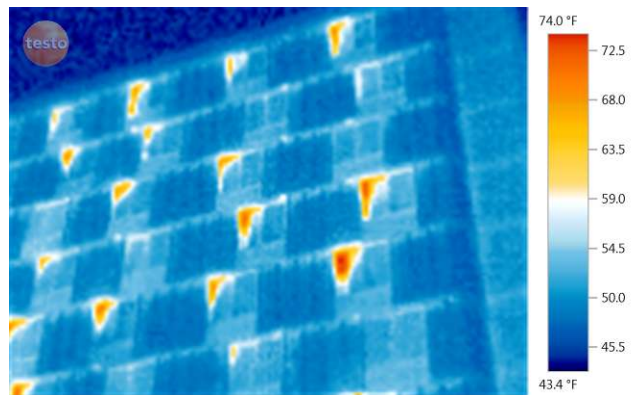
- By far the largest contribution to air leakage in the building is occupants opening windows because the spaces are warmer than desired. The thermal image below shows the pattern of open windows on a 50°F morning.

The largest concern is in reducing the overheating that is causing residents to open their windows during the heating season. See ECM #7 for recommendations.

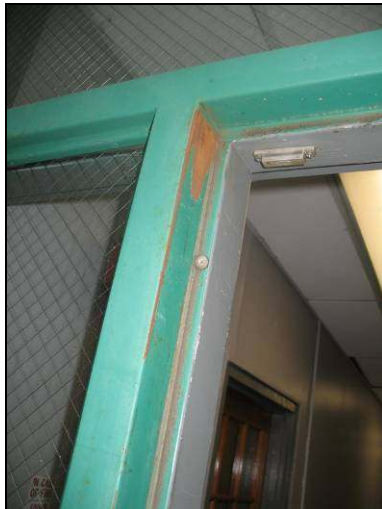
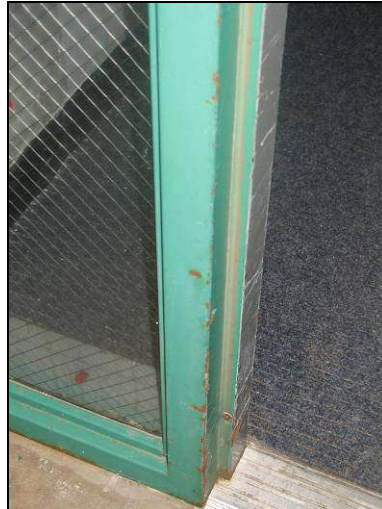
- The doors at the base of each stairwell are not sealed with weather strips or sweeps.

Other air sealing recommendations are detailed in ECM #4.

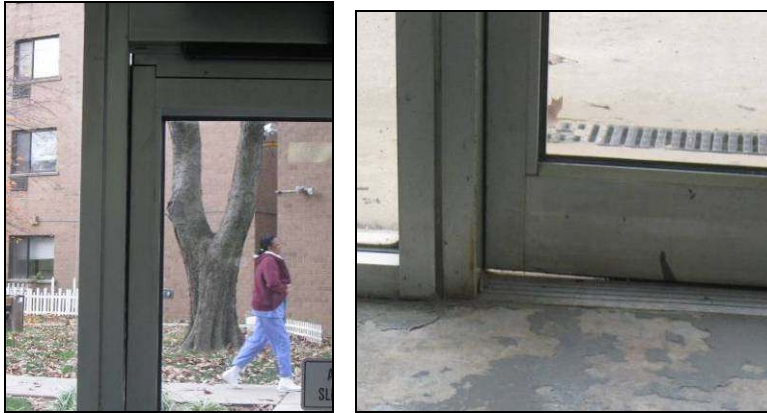
- The weather strips on the main entry doors are wearing and losing effectiveness.

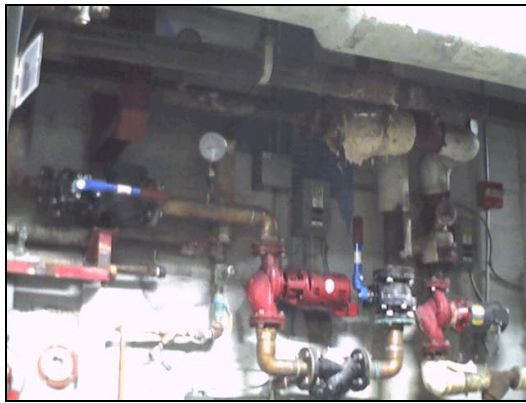
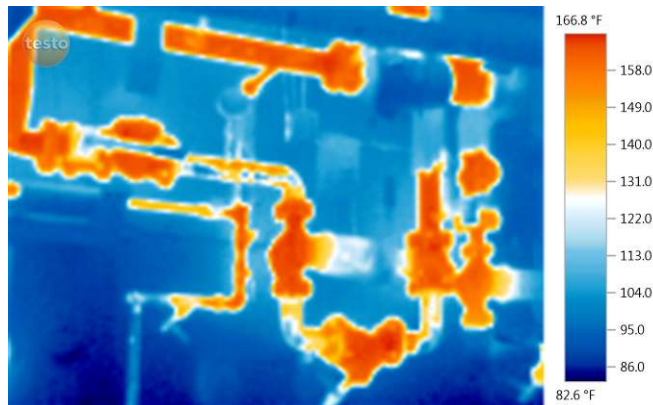
Significant heat loss was noted from hot water piping into the boiler room. Most of this heat is lost as boiler room air flows up the flue pipe and out of the building.

<p>Many of the heating system pipes in the boiler room are not insulated. These pipes are very hot and lose a significant amount of heat to the surrounding space. The boiler room is intentionally vented to provide combustion air to the boilers. Therefore, much of the heat from the steam pipes is wasted warming air that flows into the room, through the boilers, up the chimney, and out of the building.</p>

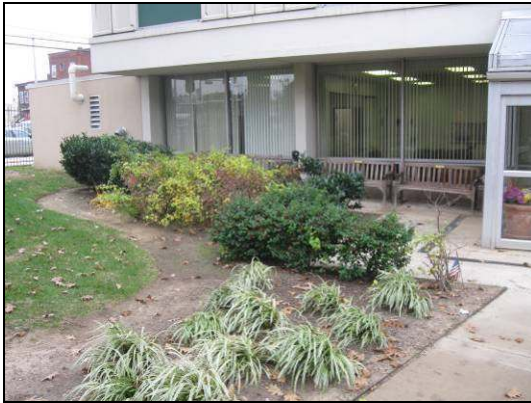
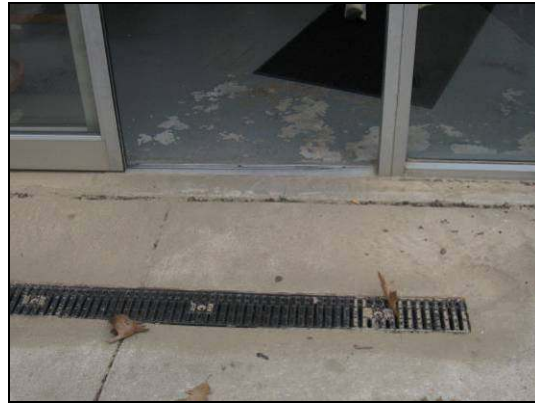
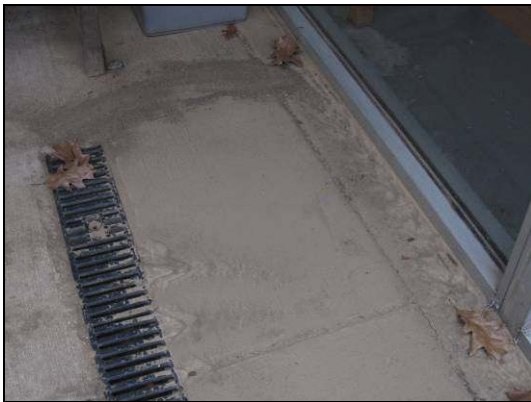
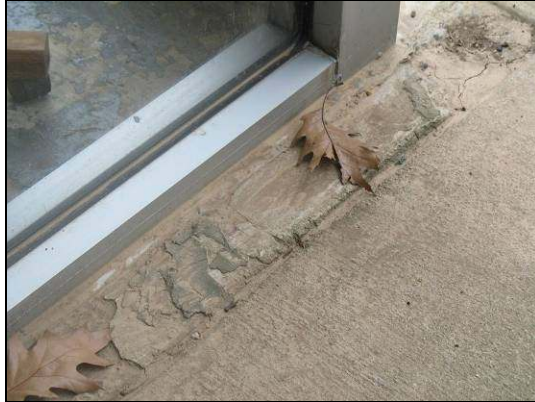
- Some intrusion of water has been experienced in the apartments at the northeast corner of the building. No clear entry point was noted. However, it appears most likely that it is occurring at either the window frames or the junctions between the wall panels and floor planks.
- Significant water intrusion occurs regularly at the north entry vestibule. The landscaping in this area is graded towards the vestibule. Drain troughs have been installed in the adjacent sidewalks, but they are not adequate to handle the flow during heavy rains.

Repairs are necessary to minimize bulk water intrusion into the building. See measure H&S #3 for details.

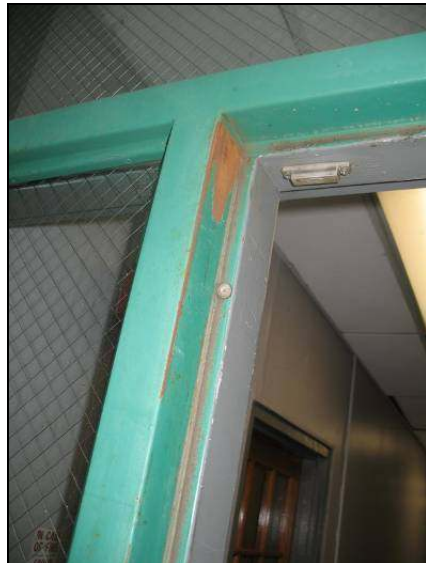
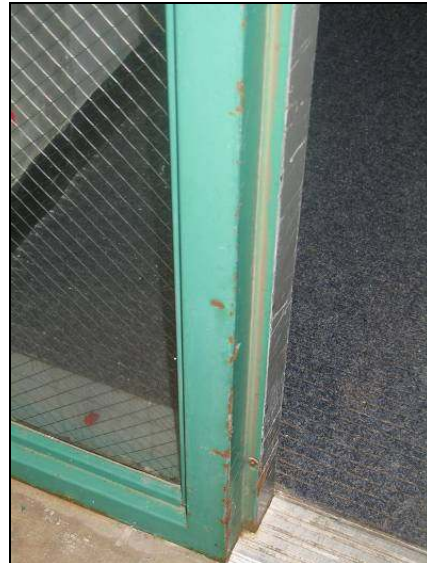
- The doors at the base of each stairwell are not sealed with weather strips or sweeps.

<p><i>Proposed Implementation Method:</i></p>	<p>Note: Compliance of each measure with local fire codes should be verified by a licensed mechanical engineer before these recommendations are implemented.</p> <ol style="list-style-type: none"> 1. Install a fan with an integral back draft damper on the ventilation opening in the laundry room wall. Install a thermostat (such as the LuxPro LV3) that only activates the fan when temperature in the space exceeds a comfortable level. <div data-bbox="643 533 1235 863">

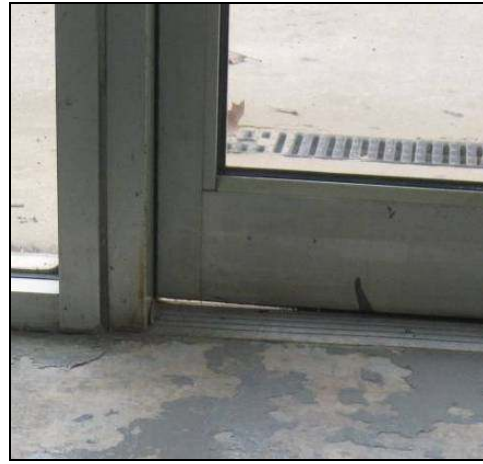
- The weather strips on the main entry doors are wearing and losing effectiveness.

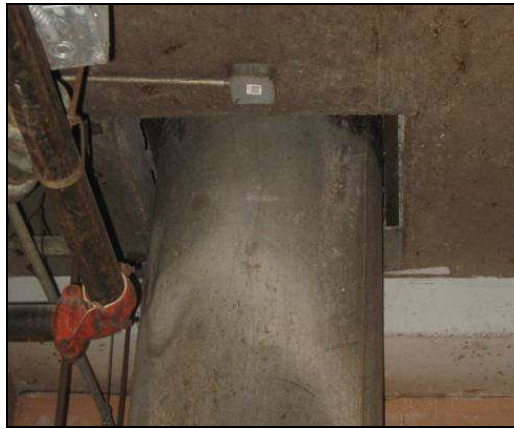
- The trash chute is not well sealed. A large opening around the chute in the compactor room allows air to enter the building through the chase around the chute. In addition, the trash chute doors have no weather strip to stop air from flowing up from the compactor rooms into the trash rooms. This issue is exacerbated by the exterior door on this room being often left open.

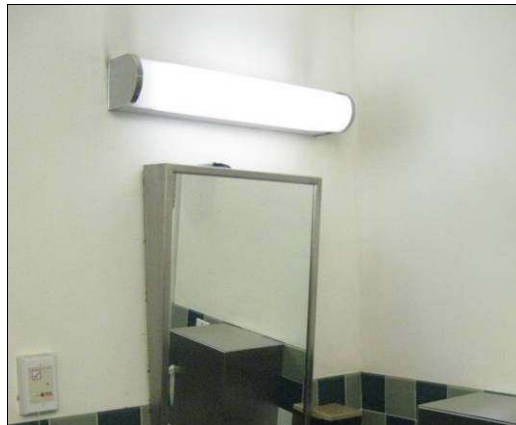
- Lights were observed to be nearly always left on in the trash rooms and compactor room, as well as the 1st floor bathroom. These could be frequently turned off with occupancy or vacancy sensors.

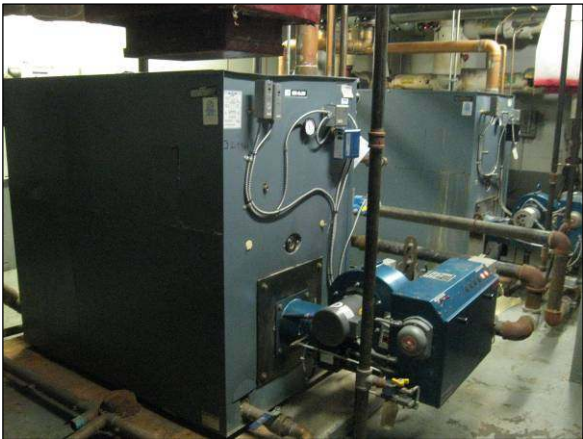
ECM #8	Boiler Replacement for Heating & DHW, plus HVAC Control Changes
<p><i>Rationale:</i></p>	<p>The building is currently heated using two atmospheric-vented cast iron sectional boilers. They have a relatively low estimated annual fuel utilization efficiency (AFUE) of 77%. Replacing these boilers with a high-efficiency condensing boiler system (Thermal Efficiency = 93+%) will significantly reduce heating gas consumption.</p>

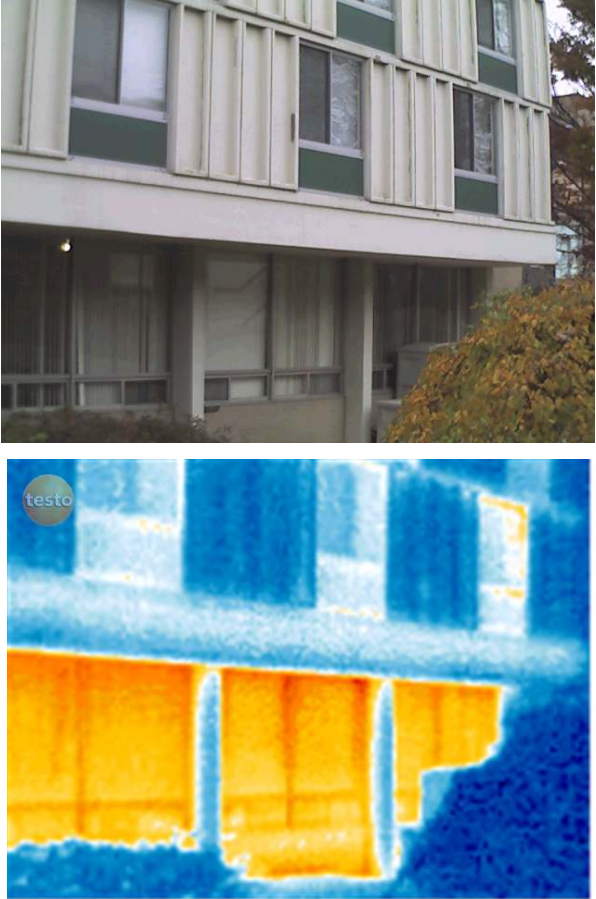
ECM #9	Replace All Original Single-Pane Windows
<p><i>Rationale:</i></p>	<p>Most of the windows on the first floor of the building are original, aluminum-framed, single-pane units. (The only exception is the windows that were installed during the 2003 expansion and renovation of the office area.) They don't offer the resistance to heat loss that modern energy efficient windows do.</p>

<p><i>Proposed Implementation Method:</i></p>	<ol style="list-style-type: none"> 1. Replace each original single-pane window with double-pane, argon filled replacement unit that includes a heat-reflective low-e coating. The new windows should have a rated U-value of 0.40 or lower. 2. Ensure that the window frames are properly flashed and sealed to eliminate infiltration of water and air.
<p>Estimated Implementation Cost:</p>	<p>\$ 48,455</p>
<p>Estimated Annual Energy Savings:</p>	<p>\$ 3,679</p>

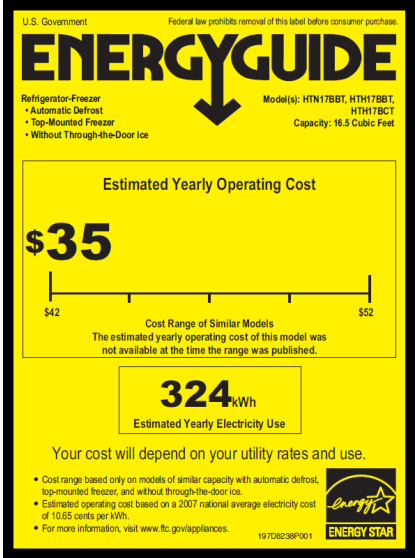
ECM #10	Refrigerators - Replace Pre-2000 Units
<p><i>Rationale:</i></p>	<p>Based on sampling at the site visits, nearly 25% of the refrigerators in the building are Kenmore models that were installed before 2000. Accounting for component wear, these refrigerators each consume approximately 800 kilowatt hours (kWh) of electricity per year. New Energy Star labeled refrigerators of a similar size can be economically purchased and use far less energy. One example is the Hotpoint HTH17CBTWW, which is rated to consume 324 kWh/yr.</p>

<p><i>Proposed Implementation Method:</i></p>	<ol style="list-style-type: none"> 1. Inspect the refrigerator in each apartment and determine its approximate annual consumption. One useful resource is: http://www.homeenergy.org/consumerinfo/refrigeration2/refmods.php. 2. Replace any refrigerators that consume more than 700 kWh/yr with new Energy Star labeled models that are rated for no more than 350 kwh/yr consumption. (The estimates below assume replacement of 30 refrigerators.)
