Multi-Family Building Energy Audit

Property Management, Inc.

City Senior Tower
456 Central Ave.
Metropolis, PA 12345

February 3, 2011

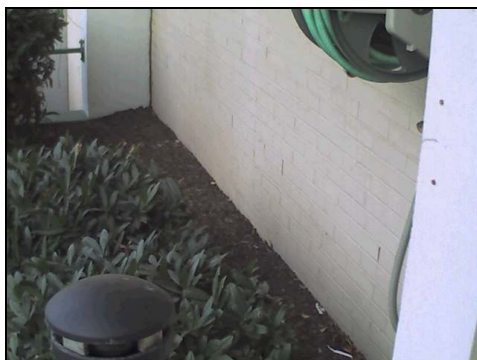
Thermal imaging shows significant heat loss at the first floor slab, indicating that no slab insulation is present. (Note the warm yellow/orange streak where the slab meets the landscaping.)

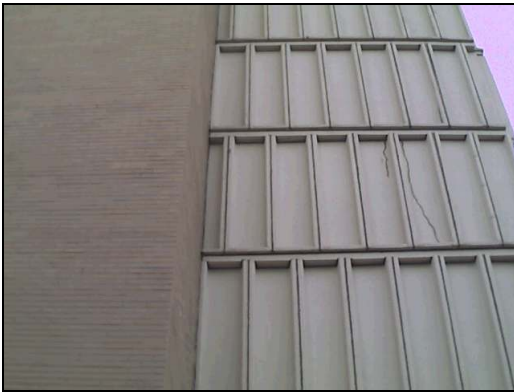
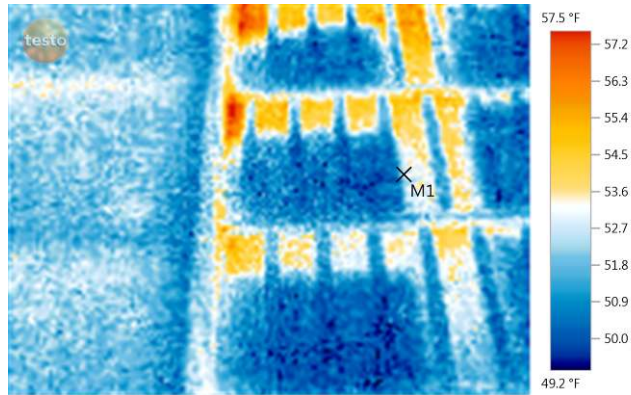
Thermal imaging on the exterior shows significant heat loss through the edges of the slabs where they protrude between the wall panels at each floor. This is also visible at the ceiling/wall junction in the interior image above.

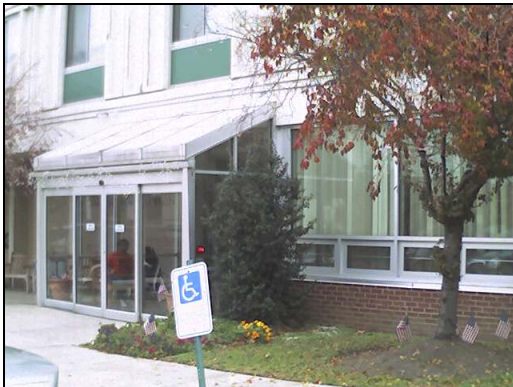
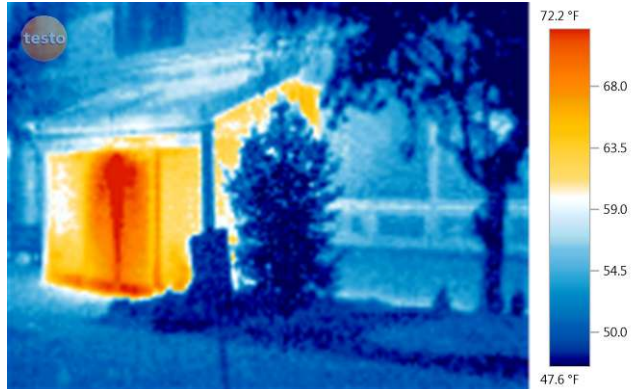
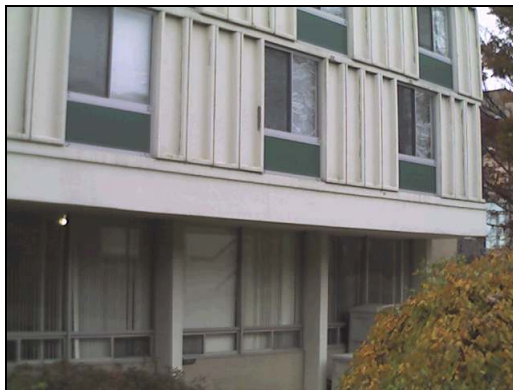
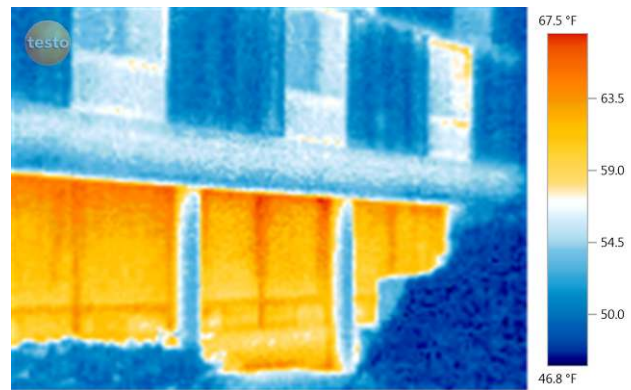
Thermal imaging shows significant heat loss through the single pane windows in the vestibule and community room. (Note the cooler surfaces on the double pane windows in the apartments and rental office.)

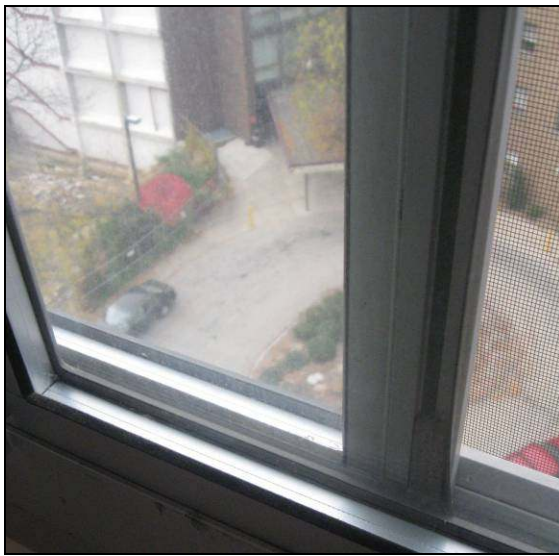
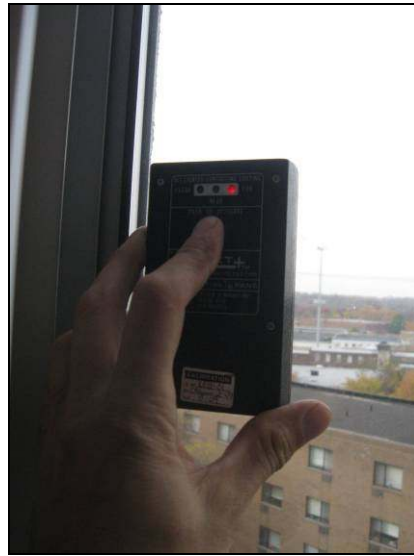
Apartment Windows:

The windows in the apartments and rental office have double pane glass and are in good working order.

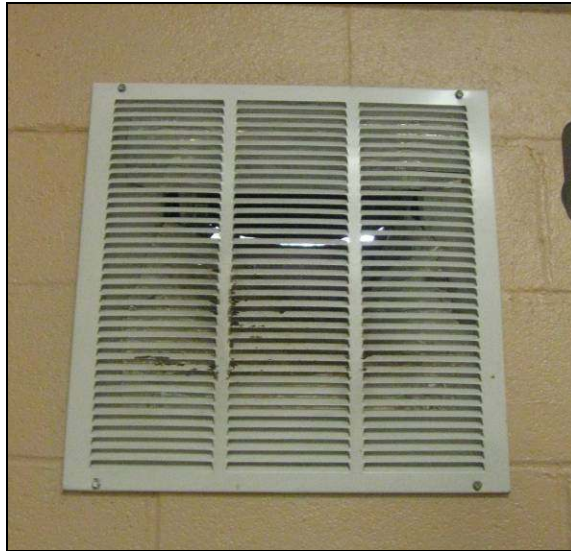
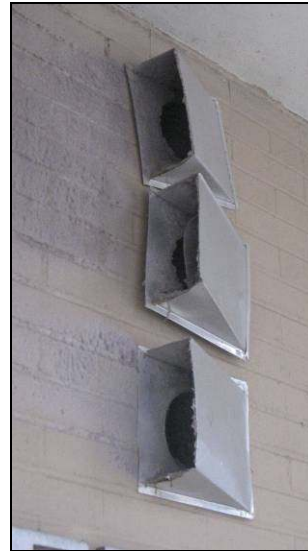
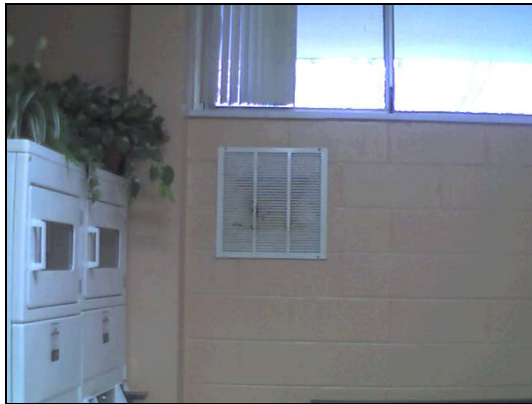
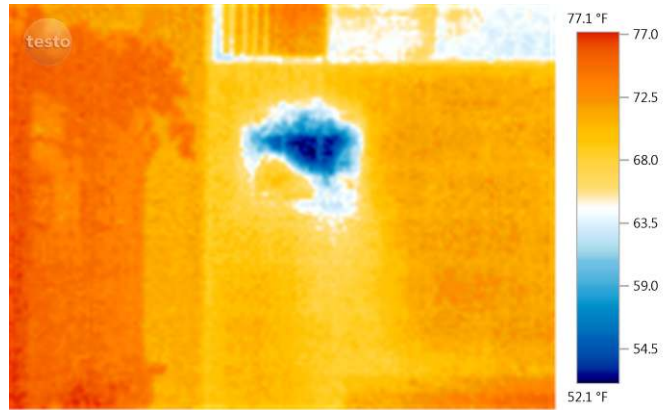
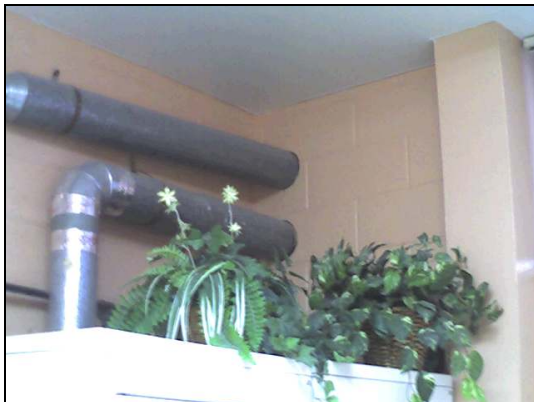
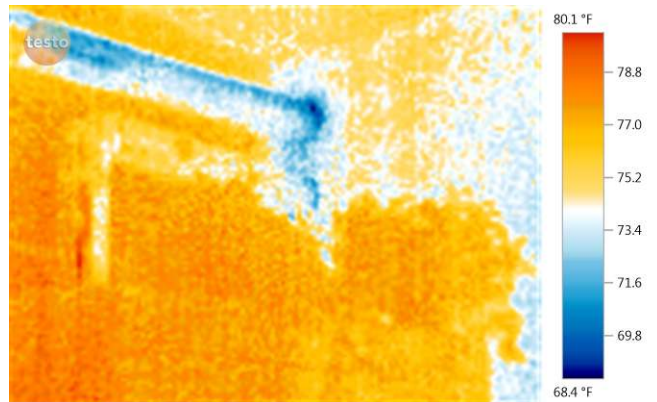
- A significant amount of outside air enters the laundry room through a ventilation opening in the wall and through the dryer outlet vents. The outlet vents are designed to be installed vertically, but are instead mounted horizontally. As a result, the integral back draft dampers do not work.

Other air sealing recommendations are detailed in ECM #4.

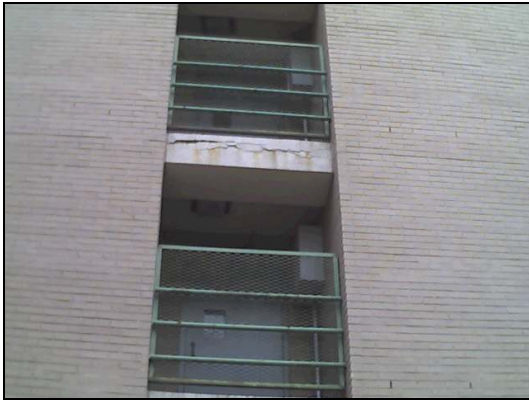
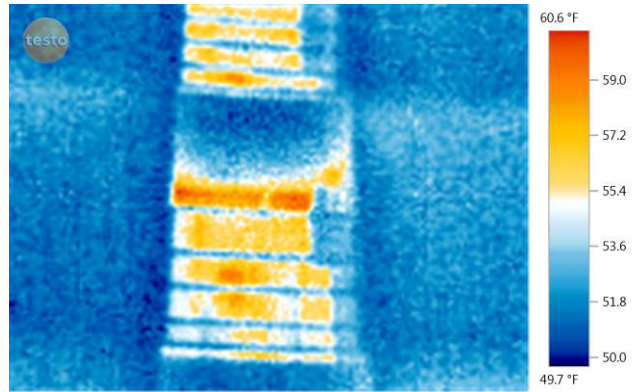
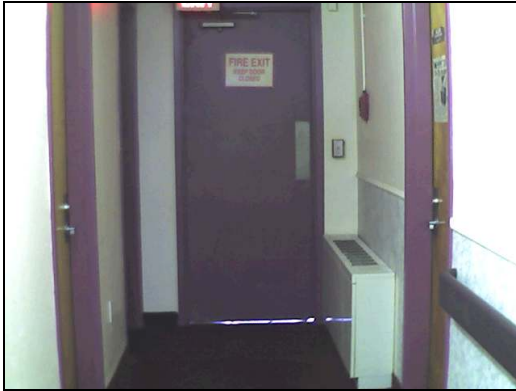
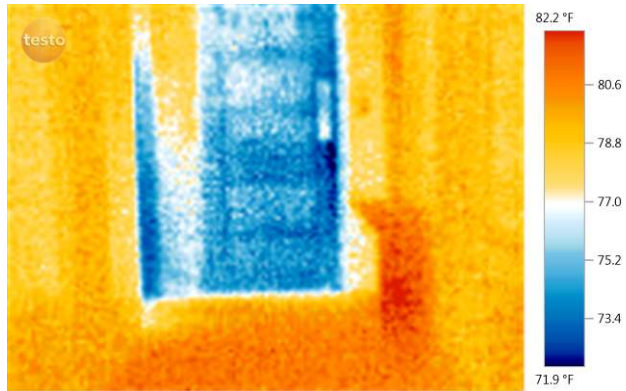
- The doors leading from the west corridors to the stairwell balconies have no weather strips or sweeps. Thermal imaging shows that they are a significant source of heat loss.

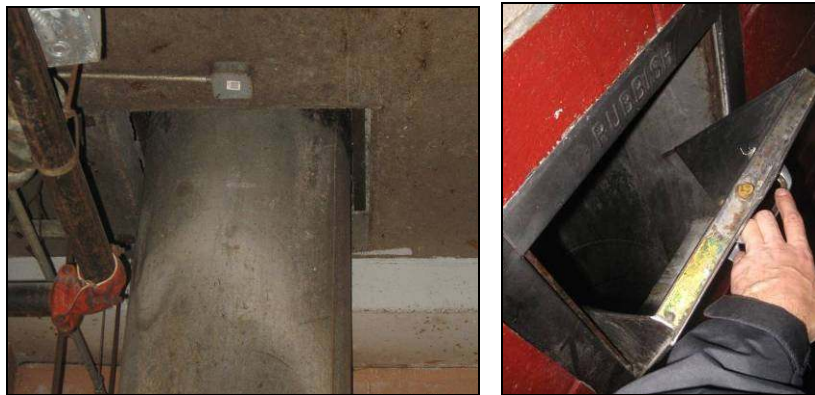
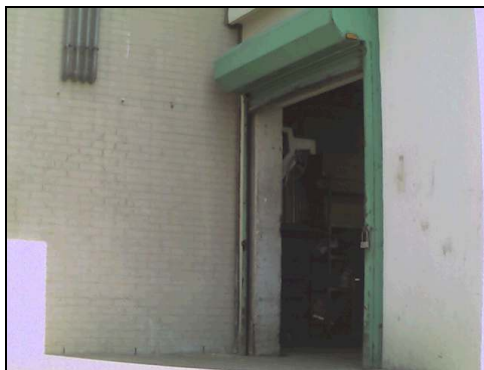
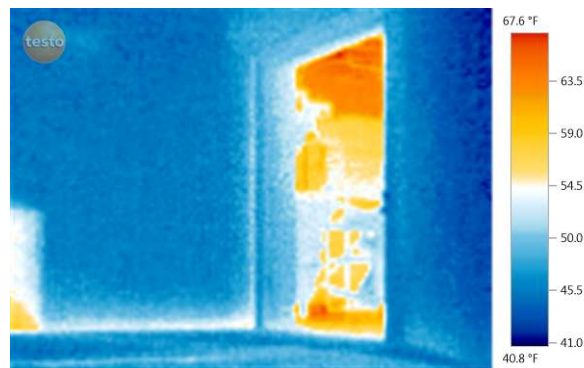
- The trash chute is not well sealed. A large opening around the chute in the compactor room allows air to enter the building through the chase around the chute. In addition, the trash chute doors have no weather strip to stop air from flowing up from the compactor rooms into the trash rooms. This issue is exacerbated by the exterior door on this room being often left open.

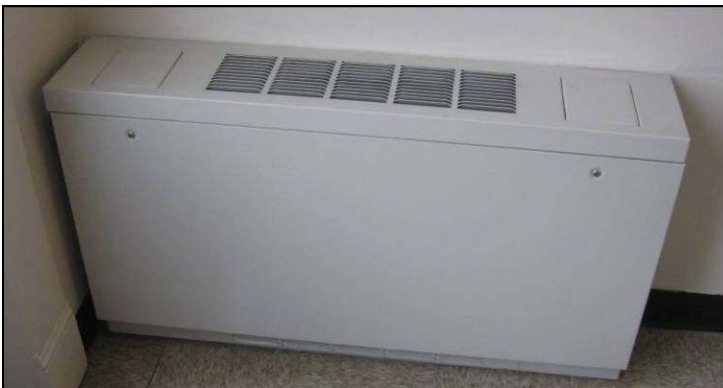
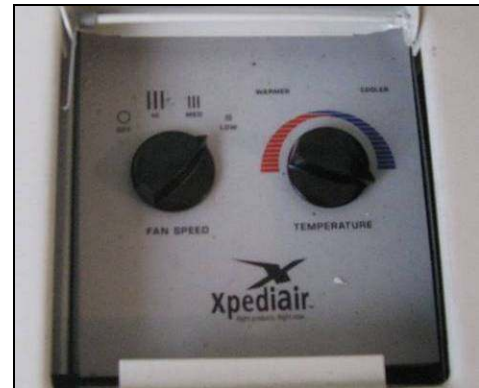
Apartment Fan Coils:

The apartment fan coils have valves to stop water from flowing through them when the thermostat temperature setting is satisfied. However some of these valves and thermostats are not functioning properly, resulting in overheating of the spaces. In addition, in numerous apartments, the residents had the fan coils operating AND the adjacent windows open.

Numerous opportunities exist to improve the operation of the heating systems. See ECM's #7 & 8 for details.

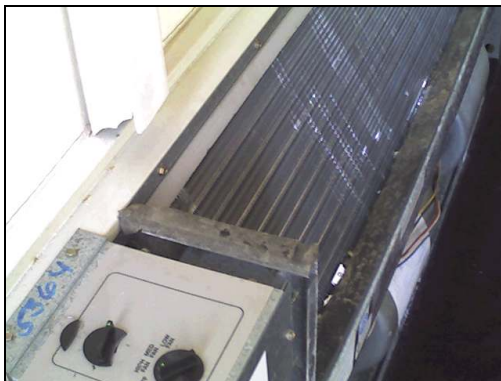
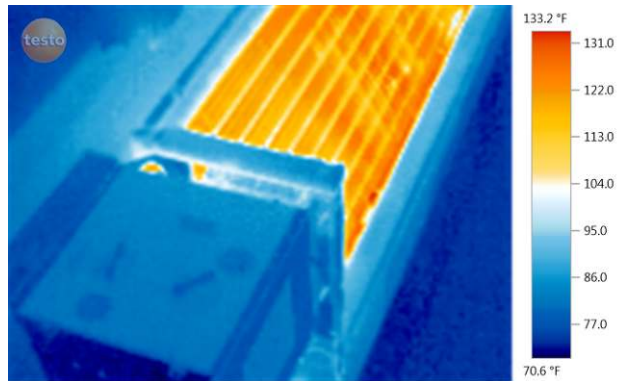
Controls Off, But Coil Hot:

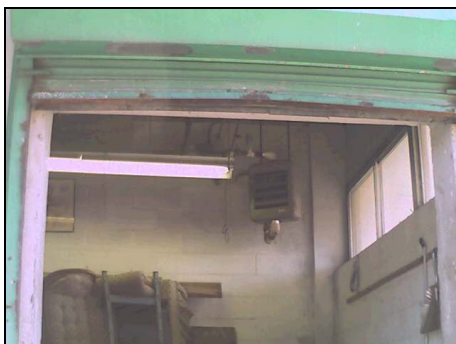
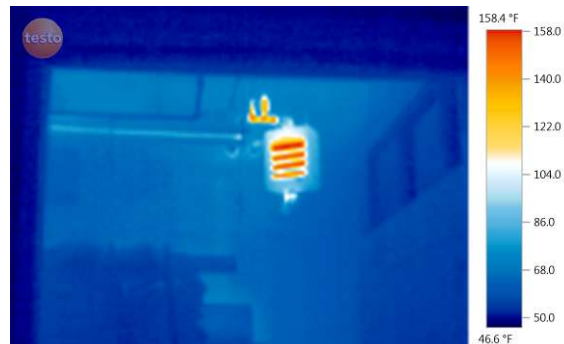
Fan Coil (in Compactor Rm)	Ceiling Mounted	<ul style="list-style-type: none"> • Running during site visits while bay door was left open.

Compactor Room – Door Open, Fan Coil Running:

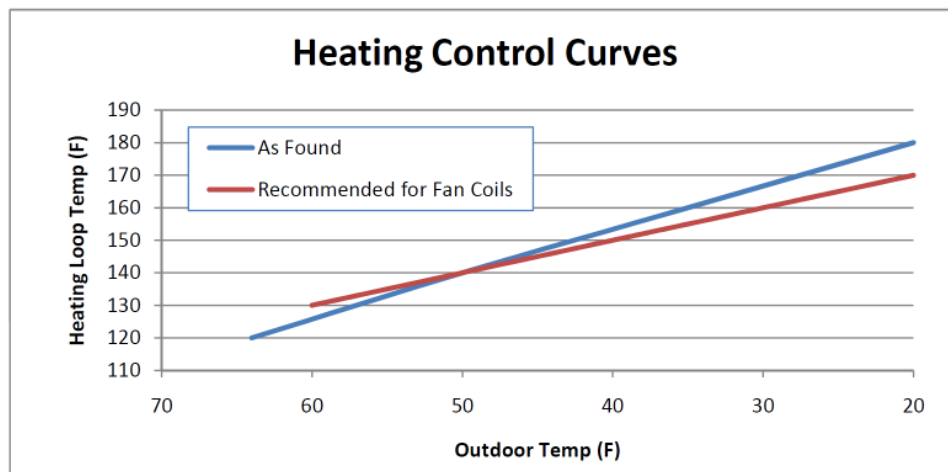
The graph below shows the heating loop temperature based on the current settings in comparison to settings recommended by a leading control manufacturer (Tekmar) for fan coil distribution systems. The settings for City Senior Tower are reasonable.

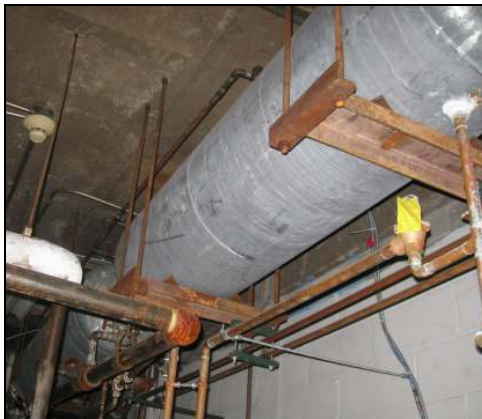
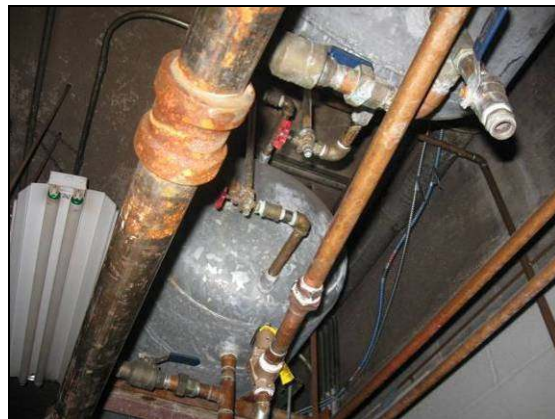
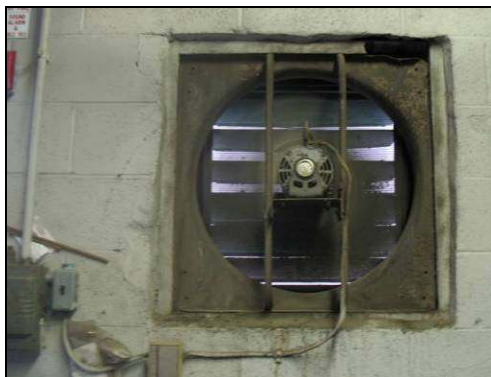
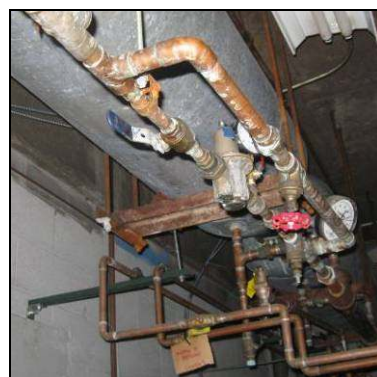
Component	Description	Notes
Auto-Fill	Pressure Regulator & Check Valves	<ul style="list-style-type: none"> Automatically fills system and maintains correct pressure.
Expansion Tank (Qty. = 2)	Original to Building	<ul style="list-style-type: none"> Non-Bladder type with sight glass. Functioning correctly at site visit.
Air Elimination	Only at Terminal Units	<ul style="list-style-type: none"> Appears to be functioning properly.
Combustion Air	Wall Room Vents	<ul style="list-style-type: none"> A supply vent with louvers is located in the electrical room adjacent to the boiler room. An exhaust vent with a thermostatically controlled fan is located adjacent to the mechanical room door.

Significant heat loss was noted from hot water piping into the boiler room. Most of this heat is lost as boiler room air flows up the flue pipe and out of the building.

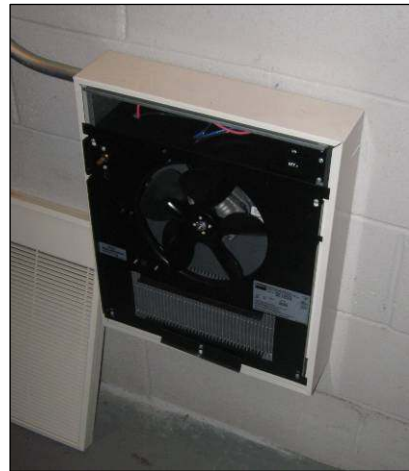
Wall mounted electric resistance heaters are used to maintain the temperature in the stairwells during the heating season. A total of 6 units are installed. One is located on the 1st, 5th, and 10th floor of each stairwell. They are Dayton #5E185D models with an output capacity of 1500W. Each has an integral thermostat (set to “Low”).

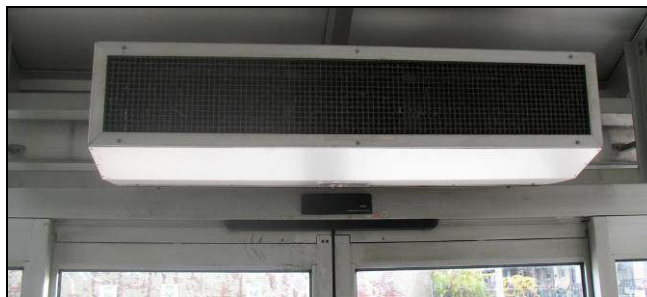
The vestibules are heated by Berner MK1-1-48E air curtain heaters. They have integral thermostats and are rated at 9500 watts.

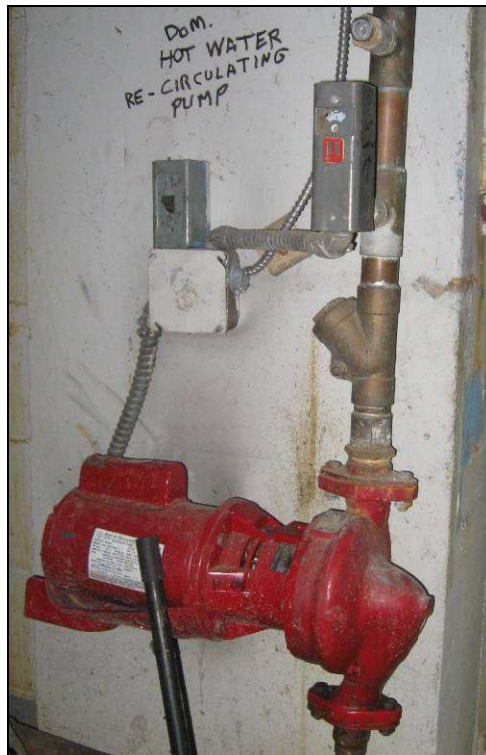
Recirculation Pump and Control:

Several opportunities exist to improve the operation of the water heating system. See ECM's #2 & 8 for details.

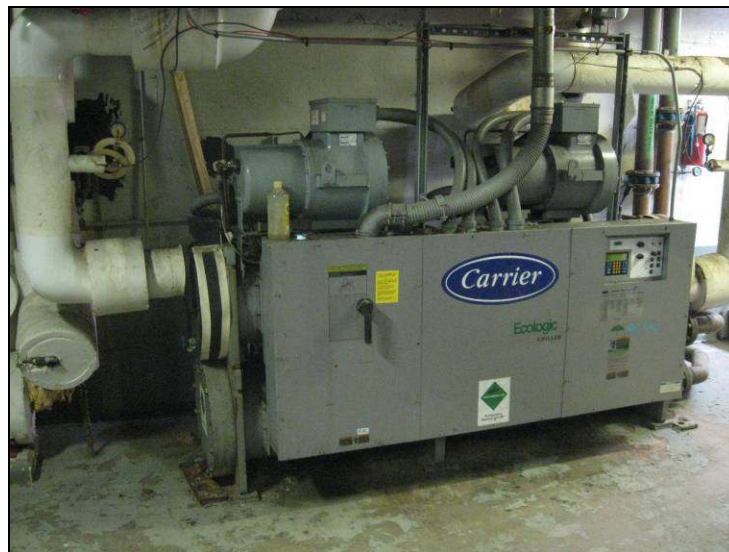
Chiller:

The cooling system is generally operating at high efficiency. However, utilizing the night setback function available on the chiller would reduce electric consumption. See ECM #8 for details.

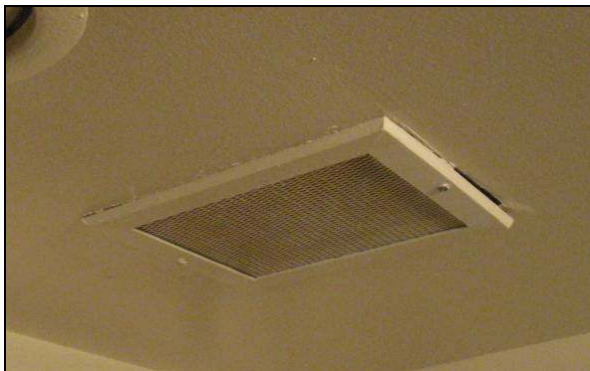
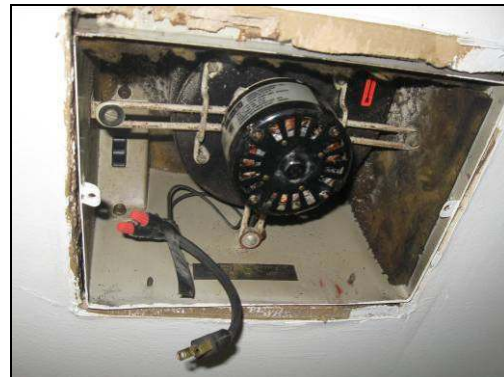
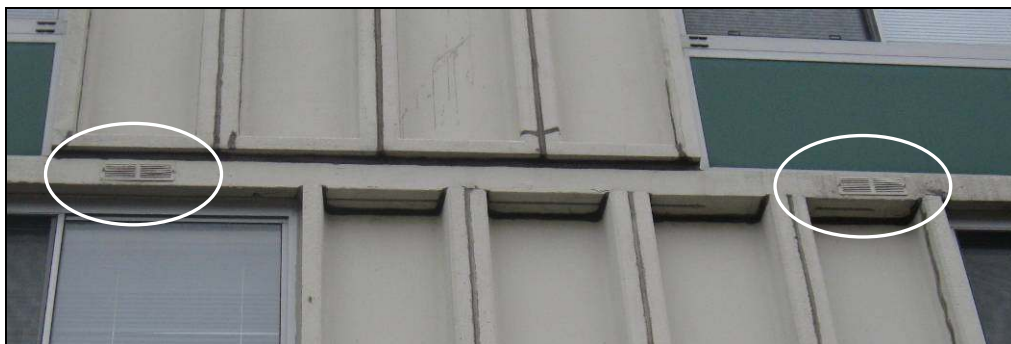
Apartment Bathroom Fans and Side Wall Vents:

The actual bathroom and kitchen exhaust flows were measured in each visited apartment. Bathroom flows averaged 14 cfm and ranged from 0 to 26 cfm. Because of the side wall venting, little variation in flow was measured from floor to floor. Fan condition was a more significant factor. In 3 of the 14 visited apartments, the fans were non-functional. In most others, they were loud enough to deter residents from using them.

The apartment bathroom fans are the primary means of removing humidity from the building. However, their effectiveness has diminished as they have aged. In numerous apartments, they have been disabled due to high noise levels. They should be replaced. See measure H&S #1 for details.

<p><i>Proposed Implementation Method:</i></p>	<ol style="list-style-type: none"> 1. Replace the existing ceiling-mounted fan in each apartment with an Energy Star labeled fan that allows continuous low speed operation and a high speed boost when the bathroom is occupied. 2. Adjust the fan to provide 15 cfm per apartment occupant of continuous flow. 3. Provide a high speed boost of at least 50 cfm that is activated (by the light switch or a motion sensor) when the bathroom is occupied. Leave the fan in boost mode for a preset period (approximately 15-20 minutes) after the occupant leaves the room. <p>One suitable example is the Panasonic WhisperGreen series, which allows the continuous flow rate to be set by a dial on the fan, and the boost to be activated by either a wall switch or an integral occupancy sensor.</p> <p>Another option is to use a different model of Energy Star labeled fan with a switch designed for ventilation applications, such as the AirCycler SmartExhaust or Tamarack Airetrak CD.</p> <p>After installation, building management can adjust the fan “on-time” or speed to suit the needs of the residents.</p>

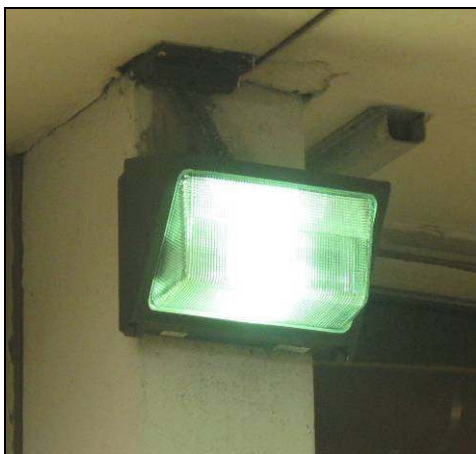
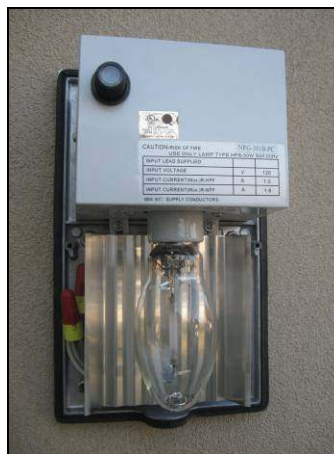
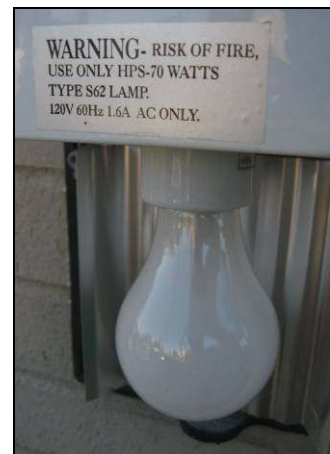
Common area lighting is a significant contributor to the very high electric consumption at City Senior Tower. This is the result of several circumstances:

H&S #4	<i>Astronomic Timer for Outdoor Lights</i>
<i>Rationale:</i>	<p>A timer is used to control some of the exterior lighting. The settings on this mechanical timer require constant adjustment due to changes in sunrise/sunset times. If these adjustments are not done, the lighting may be on during daylight hours, or there may be unlit areas during dark hours. This situation was noted during the site visit at City Senior Tower.</p> <div data-bbox="448 520 808 982" data-label="Image"> </div> <div data-bbox="829 520 1398 982" data-label="Image"> </div>
<i>Proposed Implementation Method:</i>	<p>Replace the existing mechanical timers for the exterior lighting with astronomical timers that automatically adjust for changes in sunrise and sunset times. One suitable model is the Intermatic ET8015C. This will provide more safe (and possibly more energy efficient) operation.</p> <div data-bbox="776 1192 1068 1549" data-label="Image"> </div>

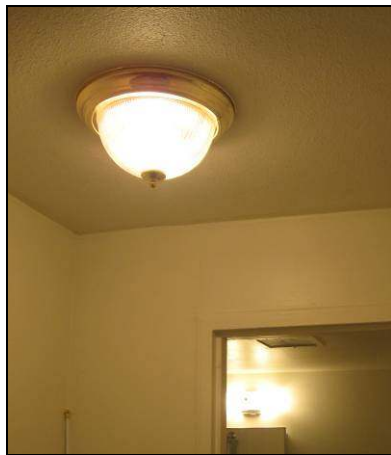
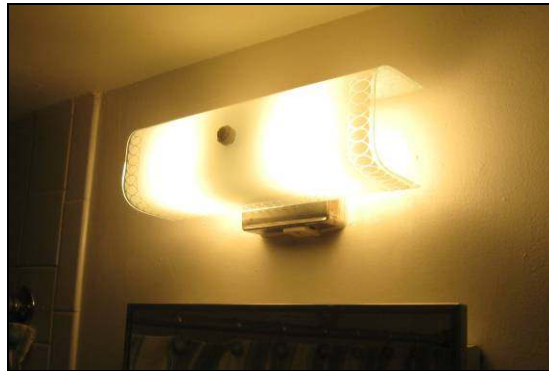
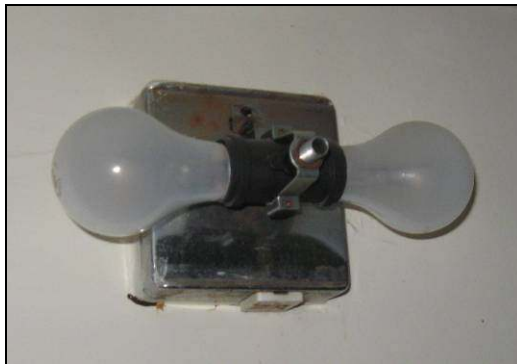
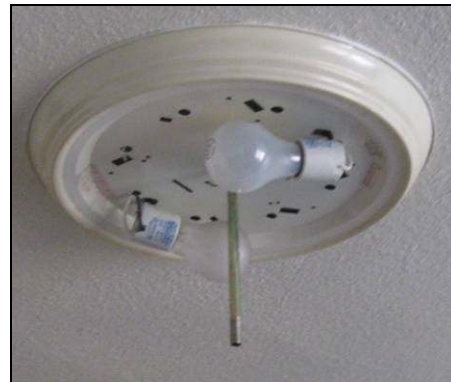
Apartment lighting is entirely incandescent. Compact fluorescent lamps (CFL's) can provide comparable lighting with 75% less electric consumption. See ECM #6 for details.

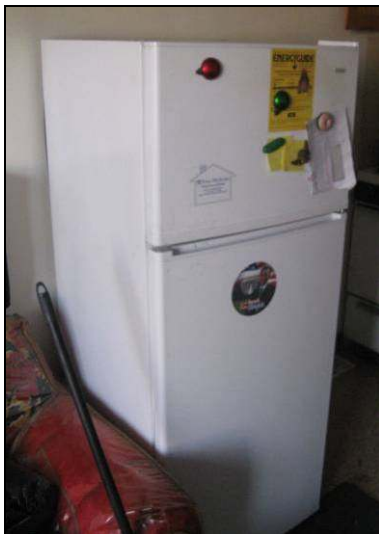
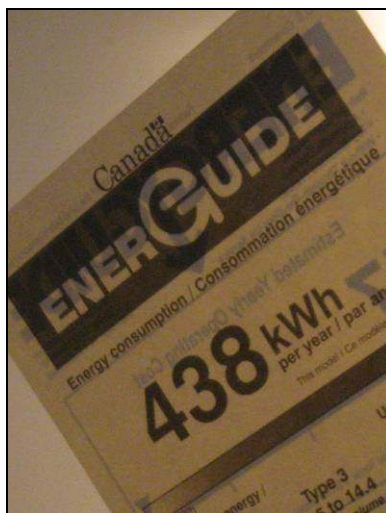
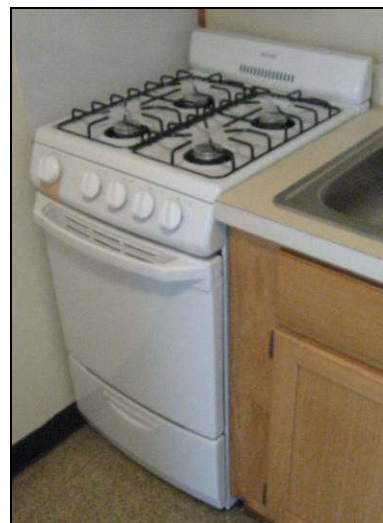
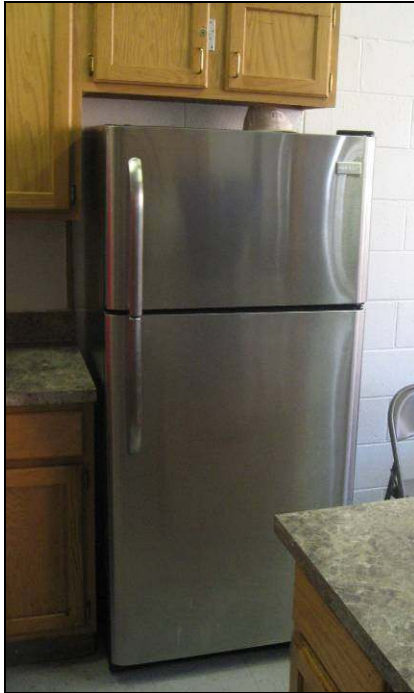
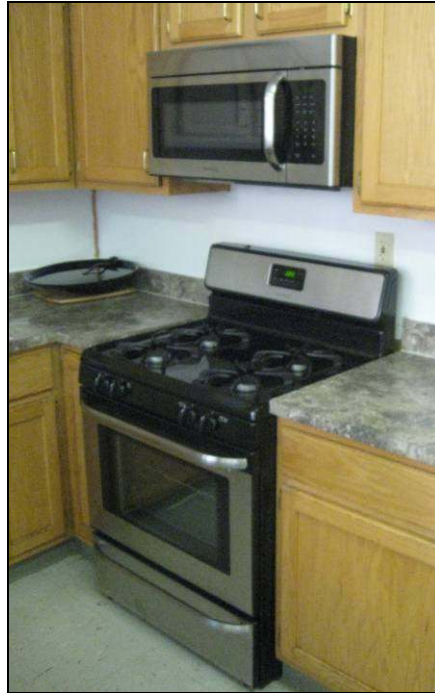
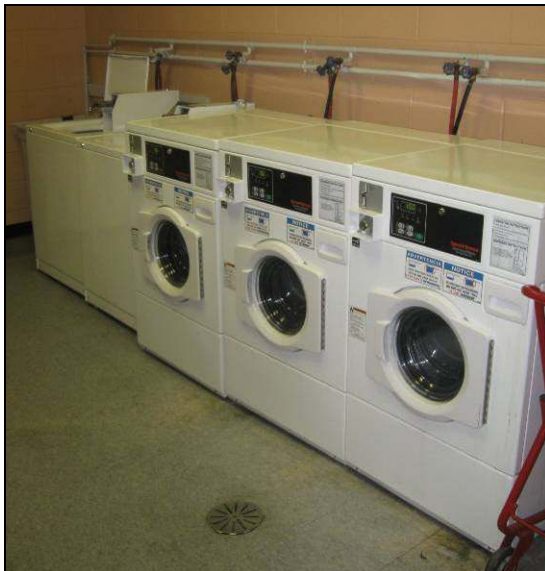
Most of the refrigerators in the building were installed in 2000 or later and use a moderate amount of electricity. However, a few inefficient 1990's models remain. See ECM #10 for recommendations.

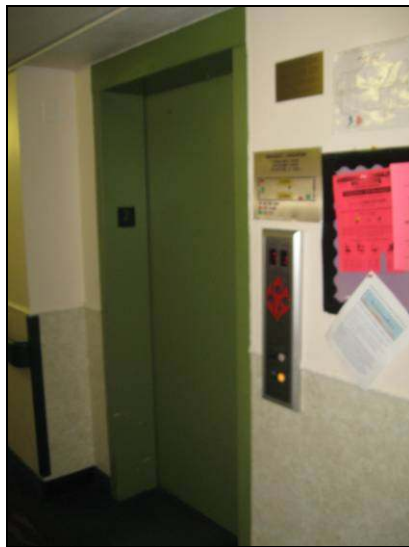
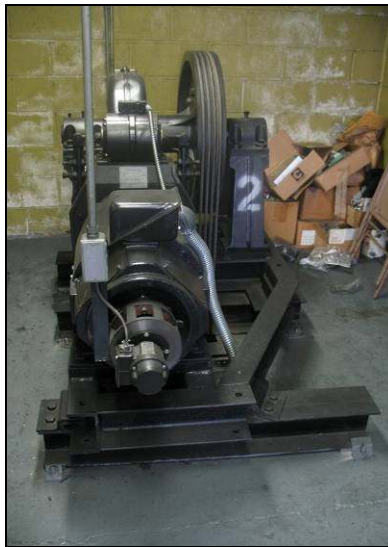
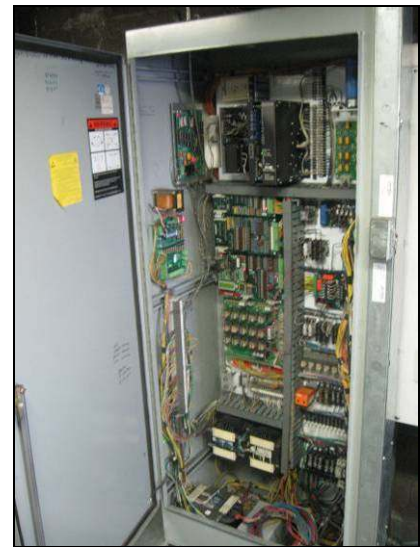
The elevators utilize inefficient gear drives, analog controls, and DC motors. However, they use little energy relative to the cost of potential improvements.

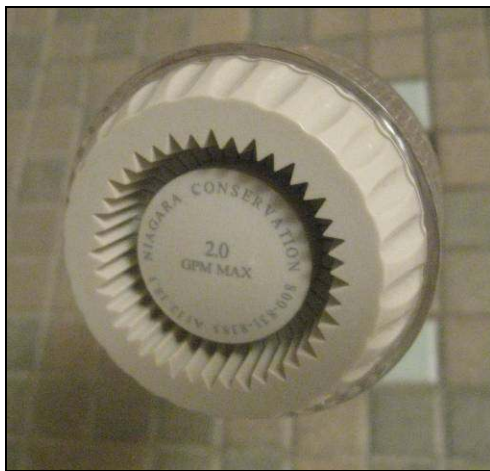
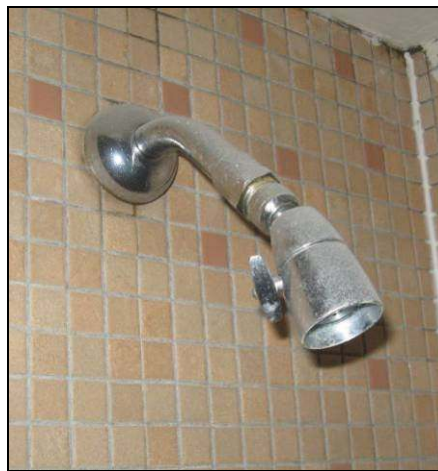
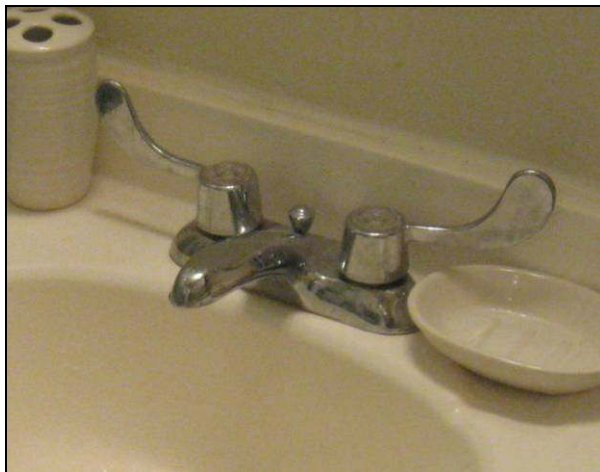
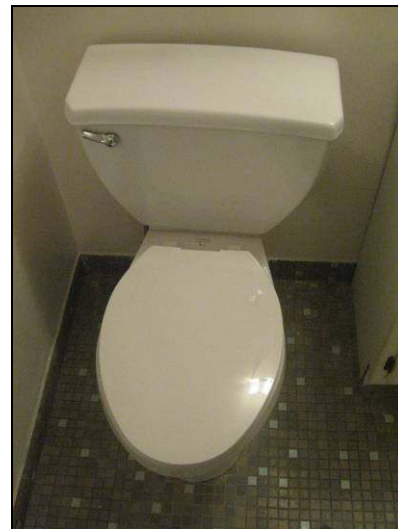
Many of the water fixtures are aging. A large number of the faucet aerators and shower heads are inefficient by modern standards. Inexpensive replacements are available that will reduce both water use and water heating energy consumption. See ECM #5 for details.

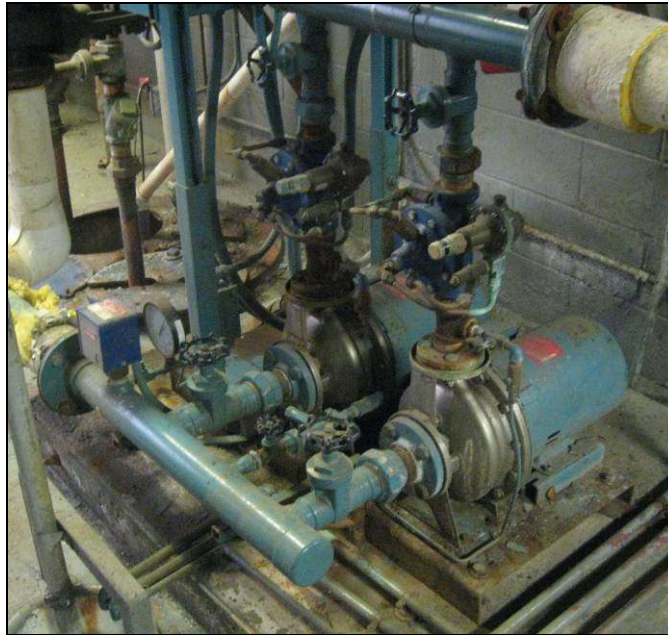
Booster Pumps:

The building uses two 7.5 hp pumps to boost the domestic cold water pressure so that it is adequate to reach the top floors. Both run at full speed at all times.

These pumps are a significant contributor to the high electric consumption at City Senior Tower.

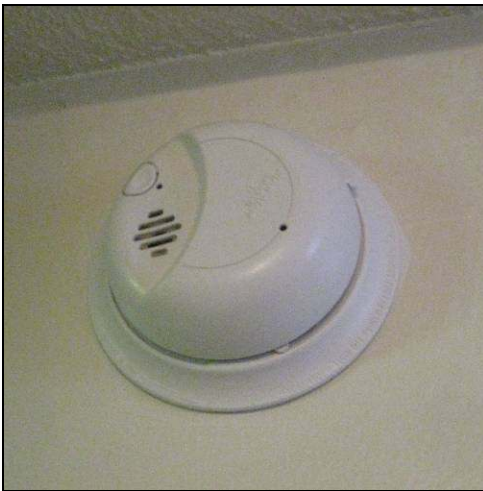
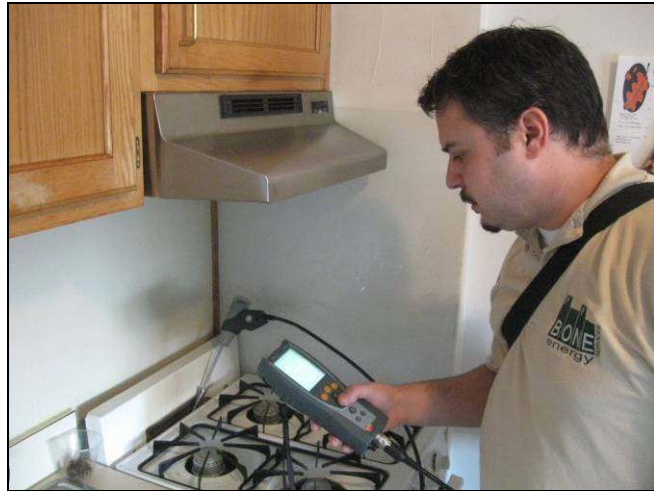
- No measurable ambient carbon monoxide was detected at any locations in the building.
- Smoke detectors are installed in each apartment, but no carbon monoxide detectors were noted in the building.
- The central boilers were tested and found to be generating carbon monoxide at levels lower than the 25 ppm action level specified by the Building Performance Institute.
- Ranges in several apartments were tested and found to be generating carbon monoxide at safe levels (lower than the 100 ppm action level specified by the Building Performance Institute).

Carbon monoxide is a significant health hazard in buildings that utilize combustion appliances. Current building codes require a carbon monoxide detector in each apartment. In addition, ranges should be tested periodically to ensure they are not generating significant levels of carbon monoxide. This is particularly important in buildings with no kitchen spot ventilation.

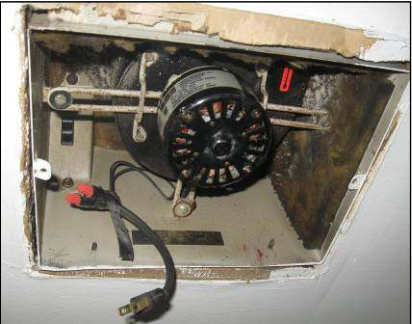
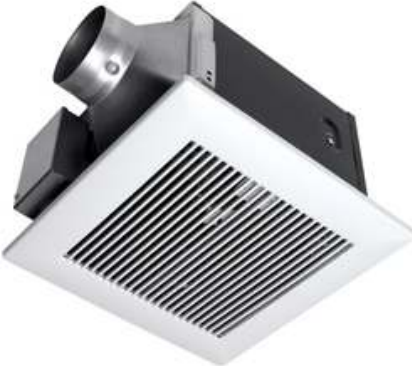
H&S #1	<i>Apartment Bath Fan Replacement</i>
<p><i>Rationale:</i></p>	<p>The apartments are currently under-ventilated according to the 2009 International Mechanical Code, which requires 15 cfm of continuous fresh air <i>per occupant</i>. This fresh air can be provided by bathroom fans which remove stale air and draw in fresh air from the corridors and through leaks in the building envelope. However, the existing fans are aging. They remove an average of only 14 cfm per apartment when powered, which would not be an adequate ventilation rate even if they were run continuously.</p> <p>Bathroom fans are available that will provide a continuous low level of ventilation air flow, and higher level of flow when necessary to remove moisture and odors from the space.</p> <p>The installation of Energy Star labeled fans will assure consistent flow, low noise, low energy consumption, and long service life.</p>

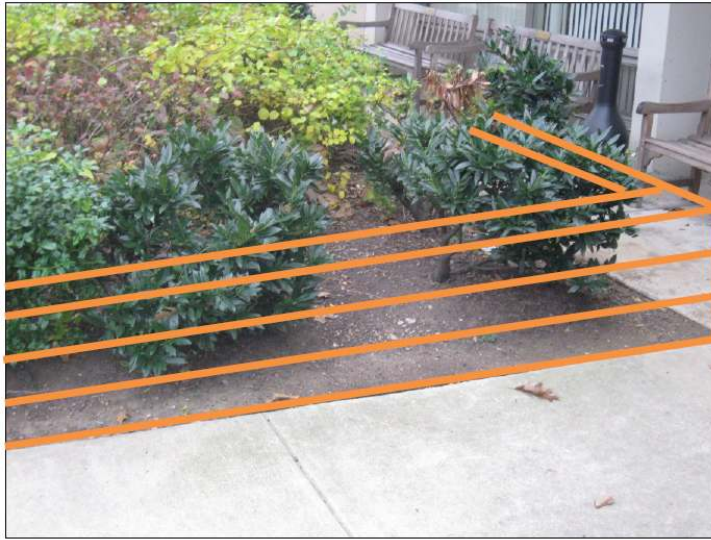
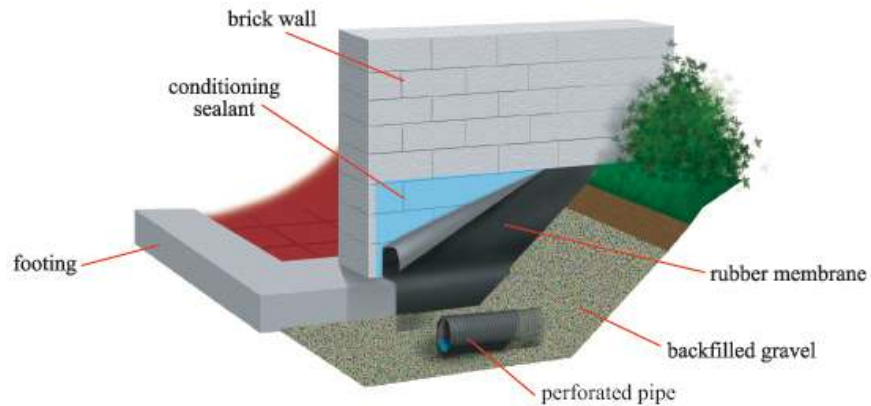
H&S #3	Drainage Improvements – Entry Bathroom Area
Rationale:	<p>Water consistently enters the north entry vestibule during heavy rains. The landscaping in this area is graded towards the vestibule. Drain troughs have been installed in the adjacent sidewalks, but they are not adequate to handle the flow during heavy rains.</p> <div data-bbox="438 489 911 846" data-label="Image"> </div> <div data-bbox="933 489 1414 846" data-label="Image"> </div>
Proposed Implementation Method:	<p>Numerous approaches are possible to alleviate the movement of significant storm water runoff towards the vestibule. The use of a retaining wall and/or swale to divert this water onto a permeable lawn is one potential solution. It is detailed below. <i>However, any solution implemented to resolve this issue should be designed and approved by a licensed landscape professional.</i></p> <ol style="list-style-type: none"> 1. Build a retaining wall along the line of the existing sidewalk to divert water around the vestibule. <div data-bbox="485 1167 1383 1841" data-label="Image"> </div>

2. Ensure that the retaining wall is at least 12" above grade.

3. Ensure that the uphill side of the retaining wall is constructed to properly absorb and divert the volume of water directed towards it. This should include a perforated drain pipe (directing water towards a storm drain or large permeable surface), gravel backfill, and transplanted landscaping. The construction would be similar to the waterproofing scheme typically used against a building foundation wall.

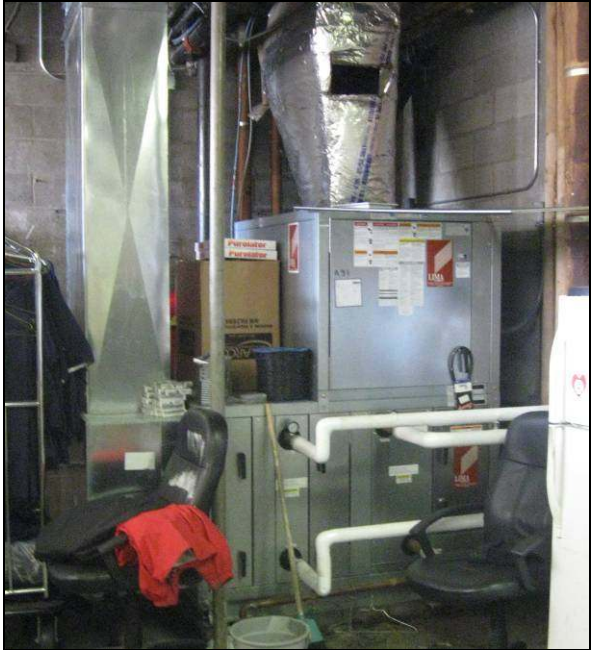
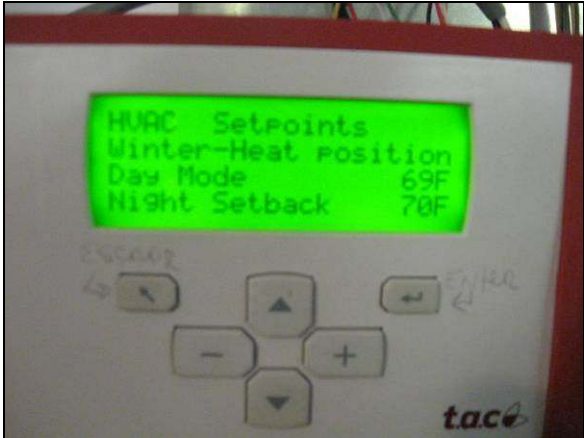
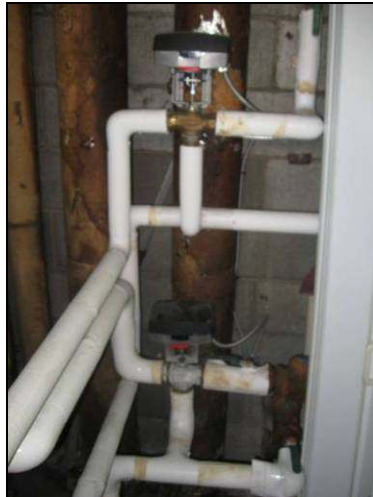
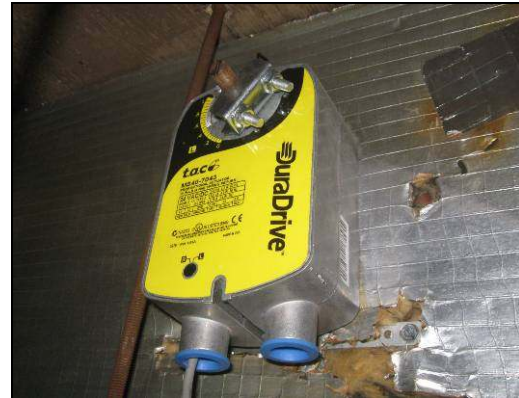
ECM #1	First Floor HVAC Controls
<p><i>Rationale:</i></p>	<p>The first floor lobby, corridor, and community room are heated and cooled by a McQuay CAH008GBAC air handler located in the maintenance room. It utilizes hot and chilled water from the central boiler and chiller systems, and it has the capability to blend both outside fresh air and recirculated room air into the return stream.</p>

<p>This air handler is controlled by a t.a.c. Xenta control system. The fan operates continuously and t.a.c. mixing valves modulate the flow of hot/cooled water to the coils to moderate the room temperature. The exact operation of the outdoor air damper was unclear but it appeared to be closed at the time of the site visit, and most likely only opens when outdoor air is cool and dry enough to be useful in the conditioning the building.</p>

The operational scheme results in excessive electrical consumption due to the continuous operation of the 4 hp air handler fan. This is especially true in the winter, when first floor heating is also provided by baseboards, so minimal heating is required from this air handler. In addition, the fresh air intake does not appear to be providing adequate fresh air to the first floor, based on the requirements specified in the 2009 International Mechanical Code.

4. Program the system to take advantage of outdoor air for cooling when the room is warm enough to require cooling and the outdoor air is at a suitable temperature and humidity level to provide that cooling.

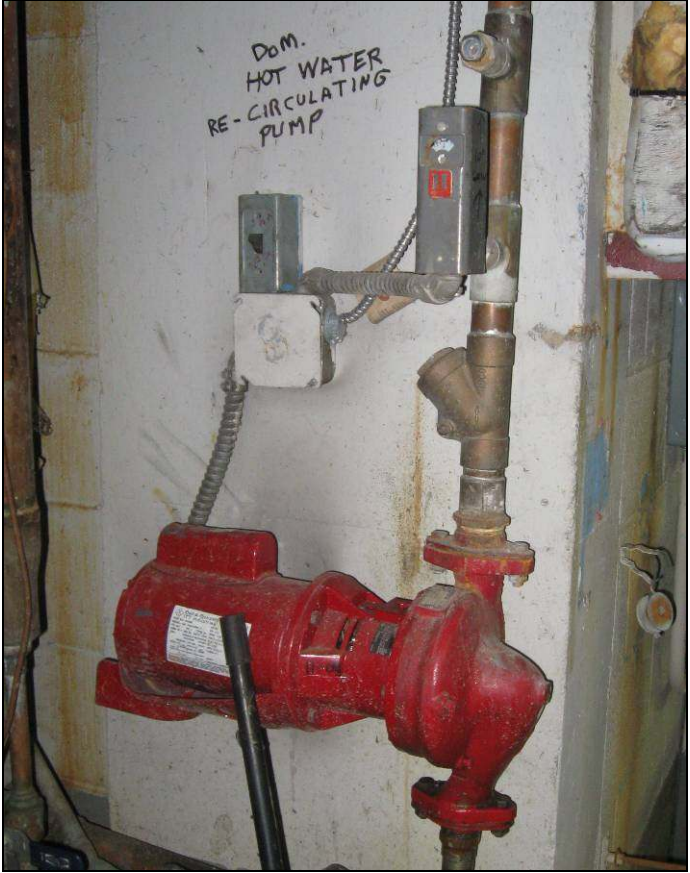
ECM #2	Hot Water Recirculation Control – Adjust Setting	
<i>Rationale:</i>	<p>A B&G ½ hp pump re-circulates domestic hot water through the building to maintain the loop temperature and keep hot water close to each apartment. A thermostat is installed that can shut this pump off until the water cools enough to require recirculation. This saves pump energy and heat loss from the circulating water when demand is negligible. At the time of the site visit this thermostat was set at 240°F. Therefore, the pump never shuts off. Studies have shown that a set point of 110°F is optimal for most buildings, minimizing energy usage while maintaining water at an adequate temperature in the loop.</p>

<i>Proposed Implementation Method:</i>	<ol style="list-style-type: none"> 1. Adjust the thermostat so the domestic hot water recirculation pump shuts down when the loop temperature is above 110°F. 2. Fine tune the set point based on tenant feedback to ensure hot water is adequately maintained in the loop.

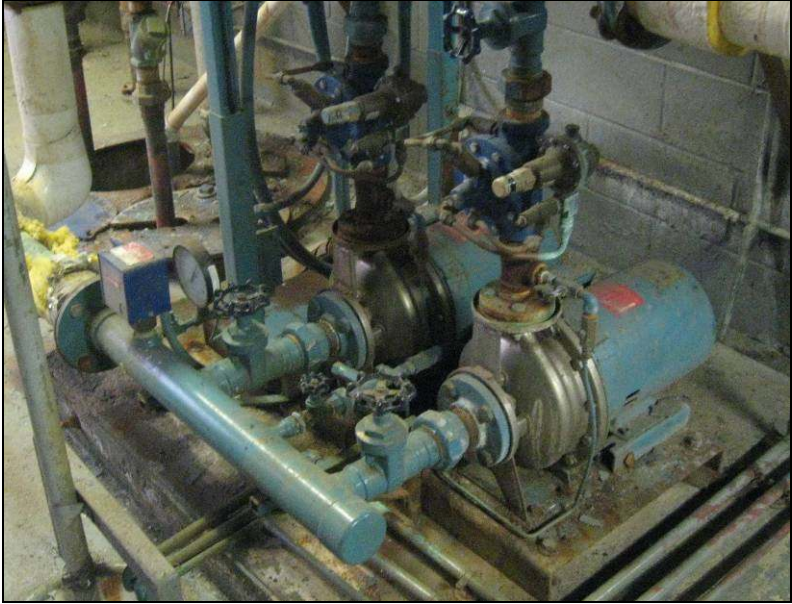
ECM #3	Variable Frequency Drives – Domestic Cold Water Booster Pumps	
Rationale:	<p>The building uses two 7.5 hp pumps to boost the domestic cold water pressure so that it is adequate to reach the top floors. Based on site observations and discussion with the maintenance staff, both of these pumps run at all times. There is no apparent means to adjust the power of these pumps based on the varying demand for water in the building. As a result, they appear to be over pressurizing the water supply most of the time in order to meet peak demand during a few small periods.</p>

<p>Variable frequency drives (VFD's) can be used to modulate the input power to pumps, providing minimal boost when demand is low and more during periods of peak demand. This provides more consistent water pressure and significantly reduces pump energy consumption.</p>	
Proposed Implementation Method:	<p>Install a pressure sensor in the main supply line and a variable frequency drive (VFD) on each pump. Use the variable frequency drives to modulate the power to the pumps to maintain the minimum pressure in the line to provide adequate pressure to the top floor.</p>
