Multi-Family Building Energy Audit

Property Management, Inc.

City Senior Tower
456 Central Ave.
Metropolis, PA 12345

February 3, 2011

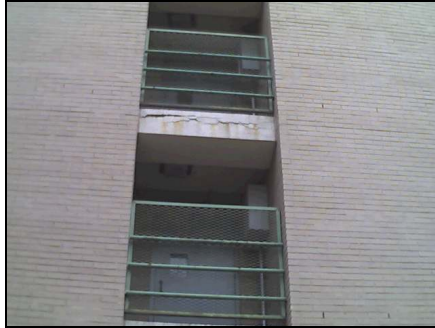
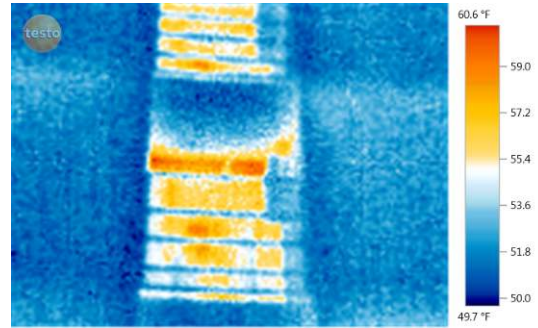
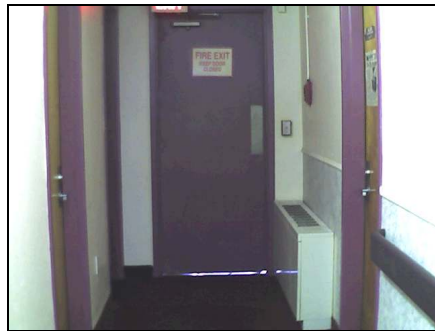
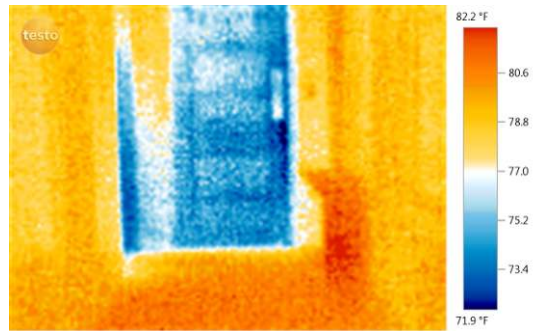
- The doors leading from the west corridors to the stairwell balconies have no weather strips or sweeps. Thermal imaging shows that they are a significant source of heat loss.

</div> <ol style="list-style-type: none"> 2. Replace the dryer vents with heavy duty models that include functional back draft dampers and ensure that the dampers are oriented so they close when the dryers are not running. 3. Install heavy duty sweeps and weather strips on the west balcony doors and the exit doors at the bottom of each stairwell. 4. Install new heavy duty sweeps, astragal seals, and perimeter weather strips on the main entry doors. <div data-bbox="1015 968 1409 1247">

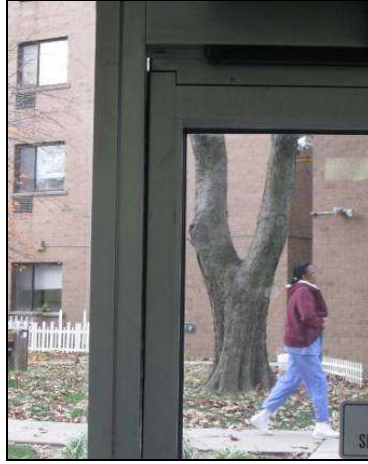
- The weather strips on the main entry doors are wearing and losing effectiveness.

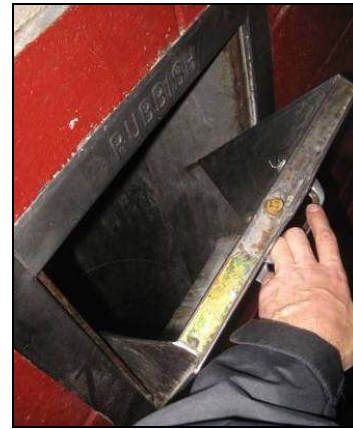
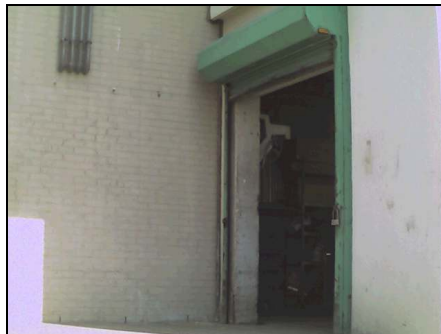
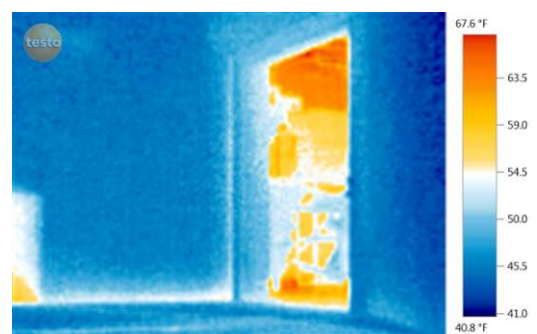
- The trash chute is not well sealed. A large opening around the chute in the compactor room allows air to enter the building through the chase around the chute. In addition, the trash chute doors have no weather strip to stop air from flowing up from the compactor rooms into the trash rooms. This issue is exacerbated by the exterior door on this room being often left open.

</div> <ol style="list-style-type: none"> 5. Seal the chase around the trash chute in the compactor room with a suitable air barrier (e.g. drywall or plywood) and spray foam. 6. Install a weather strip on the trash chute door on each floor. 7. Encourage the building staff to close the compactor room door when this space is not in use.

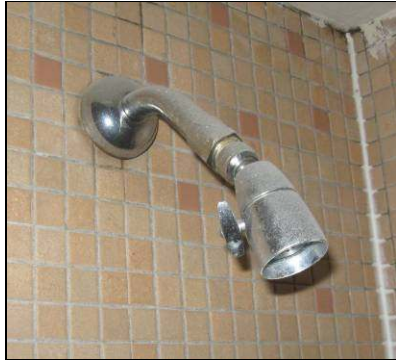
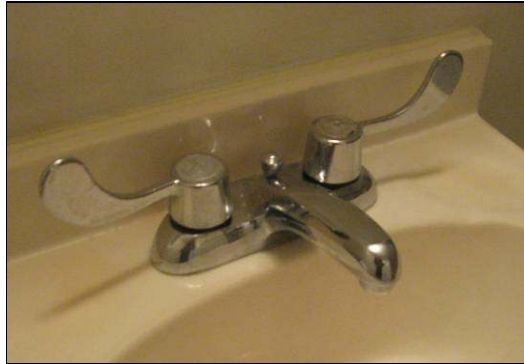
Many of the water fixtures are aging. A large number of the faucet aerators and shower heads are inefficient by modern standards. Inexpensive replacements are available that will reduce both water use and water heating energy consumption. See ECM #5 for details.

ECM #5	Low Flow Showerheads and Faucet Aerators	
Rationale:	<p>Much of the water used in a multifamily building flows through showerheads and faucet aerators. The current federal mandate for these devices is a maximum flow rate of 2.5 gallons per minute (gpm). Most of the faucet aerators in the building are 2.0 and 2.2 gpm models. Showerheads range from 2.0 to 3.5 gpm models.</p> <p>High efficiency models are available that can reduce this flow well below even the current federally mandated maximum levels. This will reduce both water consumption and water heating energy use.</p> <div data-bbox="459 598 852 955" data-kind="parent">

</div>	
Proposed Implementation Method:	<ol style="list-style-type: none"> 1. Replace all shower heads with 1.75 gpm versions. One suitable model is the Niagara Conservation Earth Massage N2917CH, which provides a variable spray pattern and reliable performance at a reasonable cost. 2. Replace all faucet aerators with 1.5 gpm versions. <div data-bbox="560 1186 885 1543" data-kind="parent">

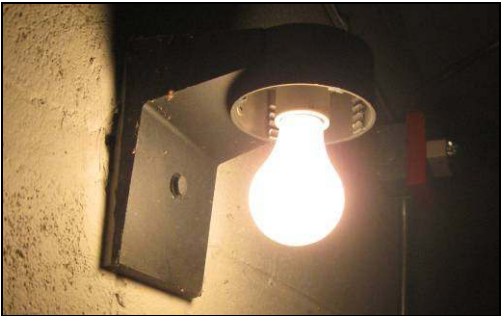
ECM #6	Lighting Upgrade Package
<p><i>Rationale:</i></p>	<p>Much of the lighting at City Senior Tower is aging and consumes more electricity than necessary.</p> <ul style="list-style-type: none"> The vast majority of the stairwell landings are lit with inefficient incandescent lamps. Because these fixtures are on 24 hours a day, they are a significant source of electric consumption.

2. Replace the incandescent lamps in the stairwells, entry vestibules, and trash rooms with 13 watt screw-in (medium base) compact fluorescent lamps (CFL's).
3. Install CFL's in the kitchen, hall, closet, and bathroom fixtures in each apartment. 13W lamps are suitable in the hallways. The kitchens and bathroom vanities would benefit from the increased output of 23W lamps.
4. Provide 2 or 3 additional CFL's to each resident for use in plug-in lamps.

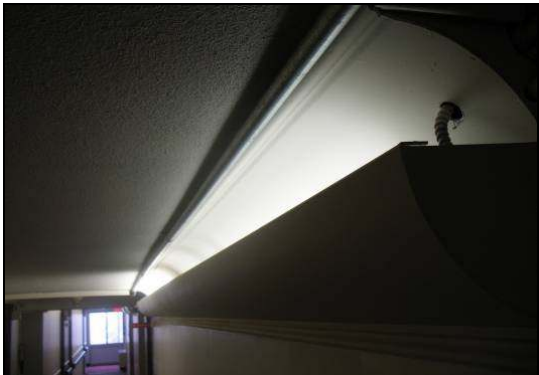
<ul style="list-style-type: none"> Fixtures in the entry vestibules and trash rooms also use incandescent lamps. The 2nd to 11th floor corridors are lit cove fixtures that absorb much of the output of the lamps, rather than directing it out at the occupied space. In addition, these fixtures utilize T-12 lamps with inefficient magnetic ballasts. These fixtures are also lit 24 hours a day.

1. Install light fixtures on the 2nd to 11th floor corridors that use fluorescent lamps with high efficiency electronic ballasts. One configuration that is very effective at providing good light distribution with low electric consumption is the use of 1-lamp, 28W, 4 ft. T8ES fixtures with electronic ballasts, mounted perpendicular to the corridor.

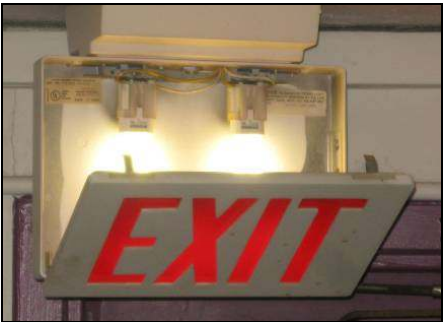
<ul style="list-style-type: none"> The exit signs on 2nd to 11th floor corridors use 2-pin compact fluorescent lamps with very inefficient magnetic ballasts. (Although the lamps are rated at 5 watts each, the total fixture draw is over 20W.)

5. Replace all of the existing fluorescent exit signs in the 2nd to 11th floor corridors with new LED exit signs.
6. Replace the incandescent lamps in the exit signs on the first floor and in the stairwells and mechanical room with LED replacement lamps.

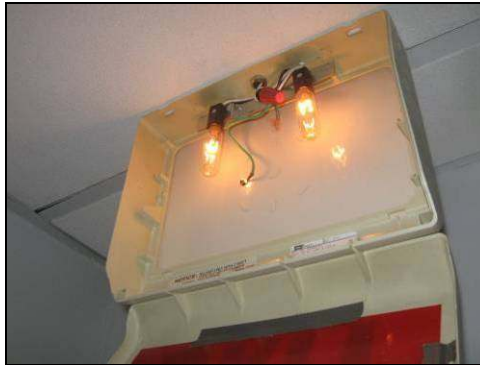
- The exit signs on the first floor and in the mechanical room and stairwells use incandescent lamps. LED exit signs use far less energy.

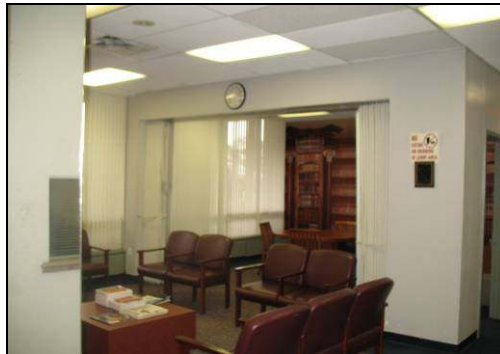
- The light levels in the lobby sitting area are higher than necessary when 4 lamps are installed in each fixture.

<ol style="list-style-type: none"> 7. Remove one ballast and two lamp clips from each of the 4-lamp troffer light fixtures in the lobby sitting area. Also, repeat this procedure on the 1st floor corridor fixtures if the building management agrees that the reduced light levels are acceptable. (Although these fixtures use magnetic ballasts, power readings indicate that they are reasonably efficient and replacement is not justified.) 8. Remove one lamp from each of the 3-lamp troffer light fixtures in the office and install a label inside the fixture instructing maintenance staff to continue installing only two lamps in these fixtures for energy saving operation. (The ballasts in these fixtures are designed for either 2 or 3-lamp use.) 9. Install switch-mounted occupancy sensors for the lighting in the trash rooms and first floor bathroom. These will automatically turn on the lights when someone enters the spaces and turn them off after sensing that occupants are no longer present. 10. Install an occupancy sensor on the light fixture in the mechanical room at the base of the west stairwell. 11. Install switch-mounted vacancy sensors for the lights in the laundry room and compactor room. These will require an occupant to activate them to turn on the lights. They will then turn off when occupants are no longer present. This will prevent lights from being activated when daylight is adequate in these spaces. One suitable model is the Lutron Maestro MS-VP600M. 12. Replace the recessed light fixtures in the elevator cars with "Air Tight" fixtures that use standard "medium-base" lamps. Install a 23W Energy Star-labeled compact fluorescent lamp in each fixture. 13. Replace the malfunctioning photo cells on the small exterior flood light fixtures and install the correct high pressure sodium lamps in each. 35W lamps should provide adequate light levels in these locations.

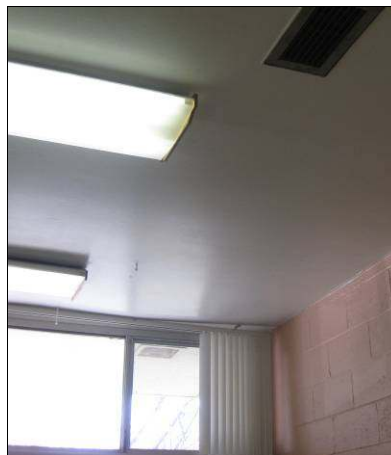
- The offices are lit to a brighter level than is necessary, particular for staff members who primarily work at computer screens.
- The laundry room lights are currently powered most of time, although there are significant time periods when the room is unoccupied.

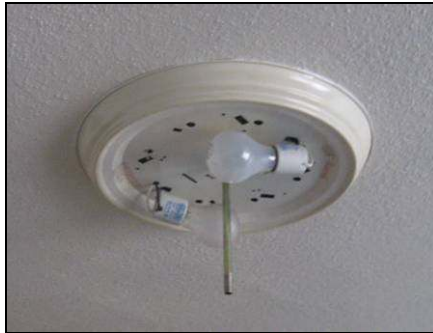
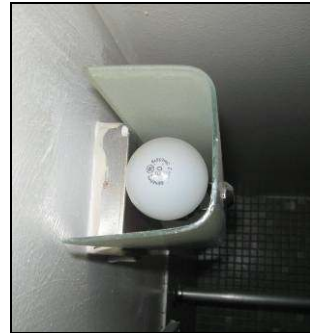
- Every fixture observed in the apartment kitchens, halls, closets, and bathroom vanities is lit with incandescent lamps. Compact fluorescent lamps (CFL's) use far less electricity to provide comparable lighting.

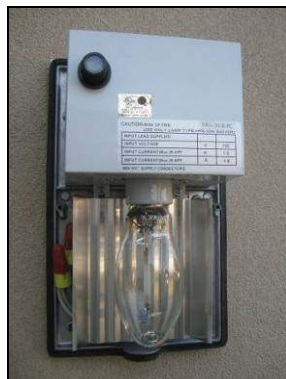
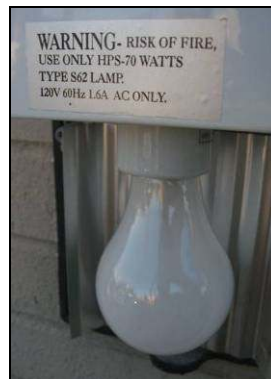
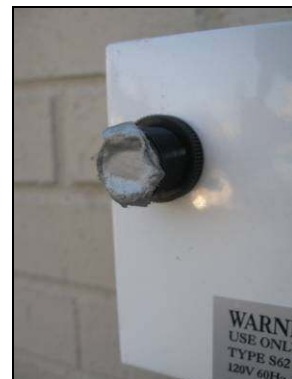
- The elevator cars are lit with recessed 2-pin compact fluorescent fixtures that utilize very inefficient magnetic ballasts. (Although the 2 lamps in each fixture are lamps are rated at 13W each, the total fixture draw is close to 60W.)
- The small flood lamps on the exterior of the building are designed to use high output, high pressure sodium (HPS) lamps, standard incandescent lamps are installed in some of them. These provide far less light output for the same energy consumption. In addition, some of the photo cells are damaged.

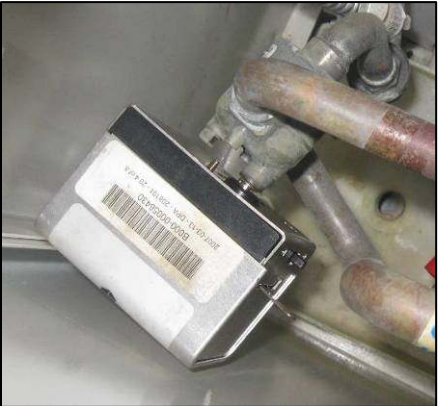
<p>Several of the water flow control valve actuators on the apartment fan coils were found to be non-functional. When they fail "Open", apartments are overheated or overcooled. When they fail "Closed", tenants are likely to be uncomfortable.</p>

<p><i>Proposed Implementation Method:</i></p>	<ol style="list-style-type: none"> 1. Install locks on the doors covering the controls on the fan coils in the apartments. Allow only the building staff to adjust the settings and encourage residents to first close windows if they are not comfortable. 2. Modify the wiring in each fan coil so that when the room temperature satisfies the thermostat set point, the flow control valve is closed AND the fan is turned off. 3. Install flow control valves in the fan coils serving the office. Wire them to open only when each thermostat calls for heating or cooling. Continue using the thermostats to also control the operation of the fans. One possible valve option is the Honeywell V4044 series, which is available for line voltage or low voltage applications. 4. Install a TRV with thermostatic control dial on each baseboard radiator serving the first floor. Adjust the settings to attain comfortable temperatures.

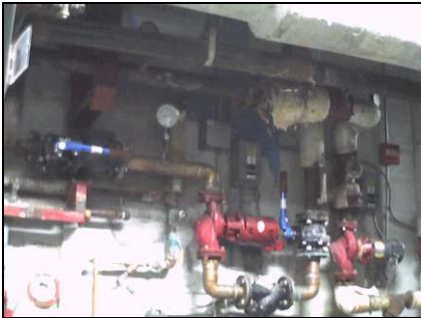
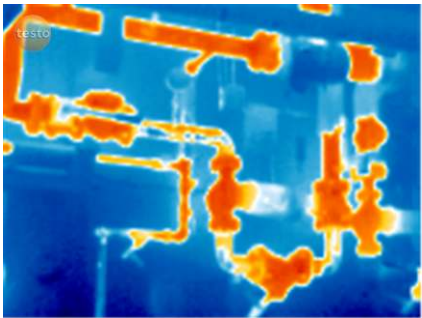
<p>Many of the heating system pipes in the boiler room are not insulated. These pipes are very hot and lose a significant amount of heat to the surrounding space. The boiler room is intentionally vented to provide combustion air to the boilers. Therefore, much of the heat from the steam pipes is wasted warming air that flows into the room, through the boilers, up the chimney, and out of the building.</p>

<p><i>Proposed Implementation Method:</i></p>	<p><i>Note: Heating system design and specification should be completed by a licensed mechanical engineer. Sizing should be completed in accordance with ACCA Manual J or N.</i></p> <ol style="list-style-type: none"> 1. Replace the current boilers with a high efficiency condensing boiler system. Energy modeling indicates a peak heating load of about 1,450,000 btu/hr (after all ECM's have been implemented). Additional capacity is needed for generation of domestic hot water. Therefore, two units with an input capacity of 1,000,000 btu/hour each should be adequate. One suitable model is the Lochinvar SYNC, which has an integral control system with outdoor reset and night setback capabilities. It also has integral controls that allow it to be used simultaneously for heating and generation of domestic hot water. 2. Install domestic hot water storage tanks designed to be heated indirectly by a hot water boiler. Generally, models manufactured by the same company as the boiler will be easiest to integrate into the system. One suitable model is the Lochinvar EGS120. 3. Install all valves, circulating pumps and electrical controls necessary to control the flow of water between the boilers and tanks. Do not circulate water continuously between the boiler and tanks. Instead, install an aquastat in each tank and configure the system so the boiler and circulator pump only run when the temperature in the tank falls below the set point (approximately 125°F). 4. Install a bladder-type expansion tank in the domestic hot water system to protect the storage tanks and distribution piping from pressure increases that can occur when the heating water expands as it increases in temperature. One suitable option is the Amtrol Extrol SX series. 5. Install R-5 fiberglass insulation on all heating and domestic hot water lines in the boiler room. It should cover all straight sections, elbows, and tees. 6. Program the chiller controls to increase the temperature of the chilled water loop be 2°F to 4°F from 11PM to 5AM. 7. Seal all combustion air openings into the mechanical room, since they will no longer be necessary with the condensing boilers.

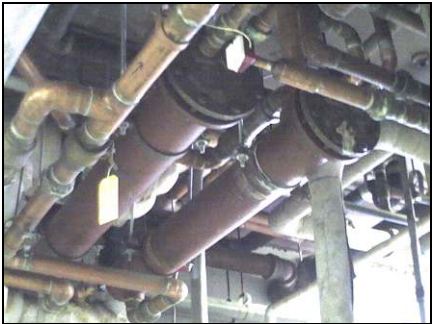
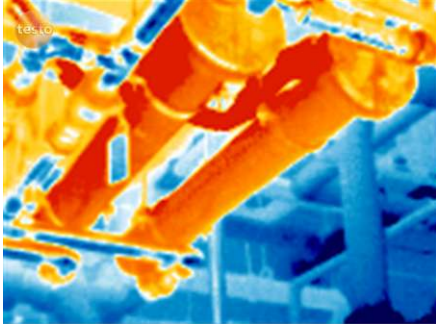
<p>Domestic hot water is generated using the heating boilers and two tankless coil heat exchangers. Because they must have a continual flow of boiler water to generate instantaneous hot water for any building demand, the tankless coils require that a ¾ hp pump run constantly to supply them. This results in significant electric consumption, as well as considerable heat loss because many of the pipes and the tankless coils are not insulated.</p>
