# Multi-Family Building Energy Audit

Main St. Apartments  
123-135 Main St.  
Smalltown, PA 12345

*April 8, 2010*

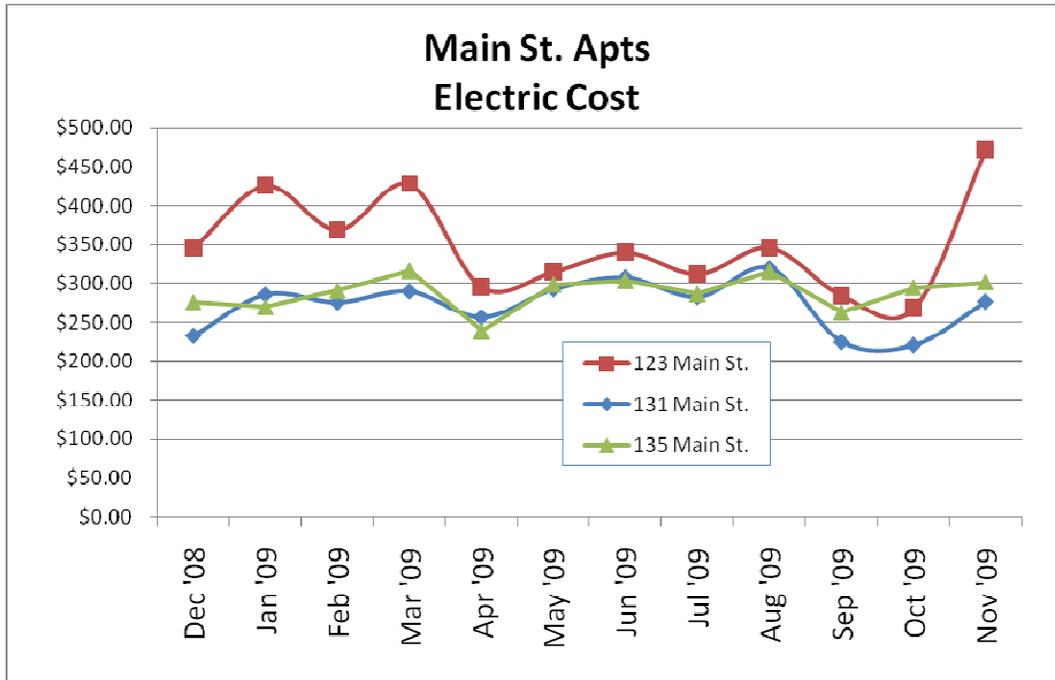
It is assumed that the apartment electric usage is much higher than that of the common areas because each apartment includes lighting and appliances. Most apartments also use window or sleeve air conditioning units.

The common area electric usage levels are moderate, and the patterns are typical for a facility heated with natural gas and with no central cooling. The lowest cost months occur during the spring, summer, and fall when no heating is in use. Consumption in these months can be considered to be the “baseload” that corresponds to year-round usage for lighting and laundry appliances. For the entire complex, baseload accounts for about 86% of total use. In the winter, the remaining 14% is consumed by the heating systems (primarily pumps).

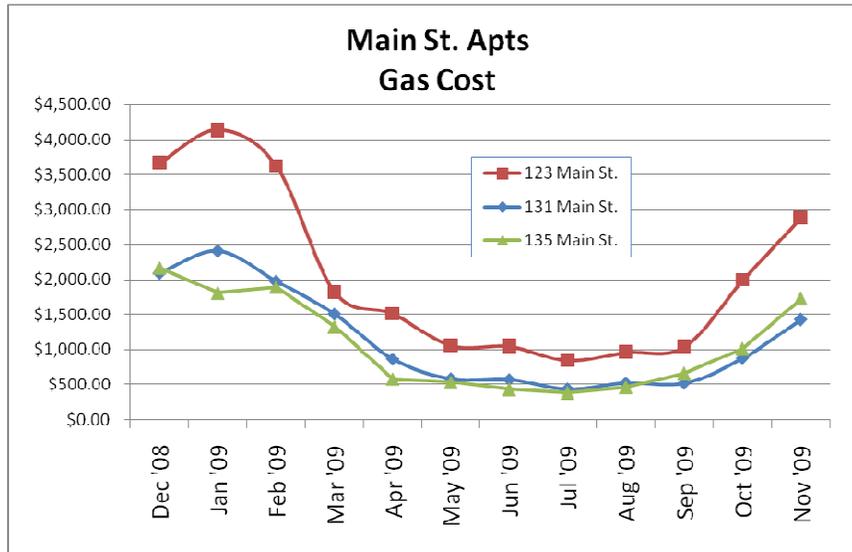
Consumption trends are typical for a building using natural gas for heating and domestic hot water. Heating usage begins in October, peaks in January, and ends in April. Water heating usage is fairly steady, with the lowest usage in the summer months. It increases in the colder months due to the need to heat colder incoming water from the street and the added heat loss from the pipes that are circulating through a building that is maintained at a lower temperature.

The steady consumption in the spring, summer, and fall months (approx. 1350 therms/mo) can be considered to be the “baseload” that corresponds to year-round usage for domestic water heating and cooking. This accounts for about 47% of total use. The remaining 53% is utilized for space heating. These are fairly typical proportions for family housing.

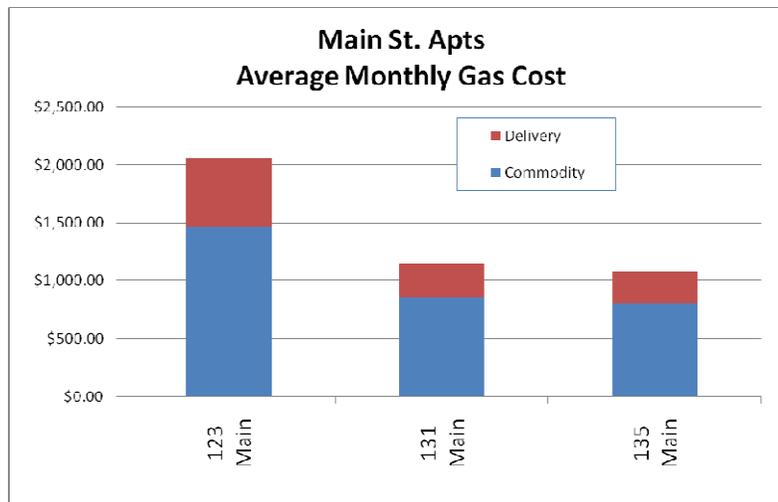
Natural gas is delivered by PSE&G, but the gas is purchased from Hess. The total cost is 63% gas (commodity) and 27% delivery.

Overall, the gas cost per building is as follows:

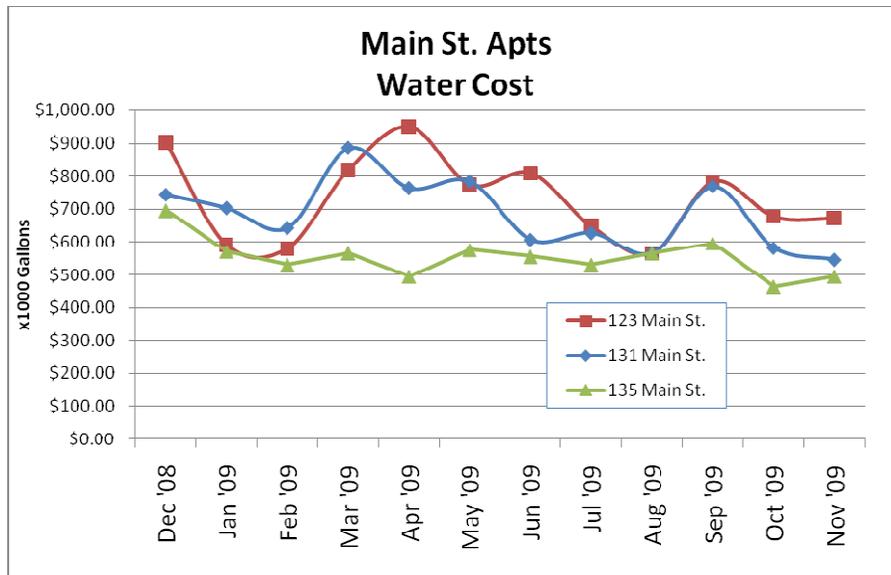
Annual water use for the buildings totals about 4,680,000 gallons, at a cost of \$23,633. This translates to an average use of 151 gallons per apartment per day. According to HUD data, this is about 56% more water use than a typical building of this size. Water usage fluctuates throughout the year with no apparent patterns. This may be due to leaks.

<b>Results</b>	<b>Your Building</b>	<b>HUD Typical</b>
	<b>Score Against Peers</b>	<b>22</b>
Annual Water Use (gal/year)	4,677,000	3,001,399
Annual Water Use Intensity (gal/ft <sup>2</sup> -year)	67.8	43.5
Annual Water Cost Intensity (\$/ft <sup>2</sup> -year)	0.34	0.22
Total Annual Water Cost (\$/year)	23,633	15,166

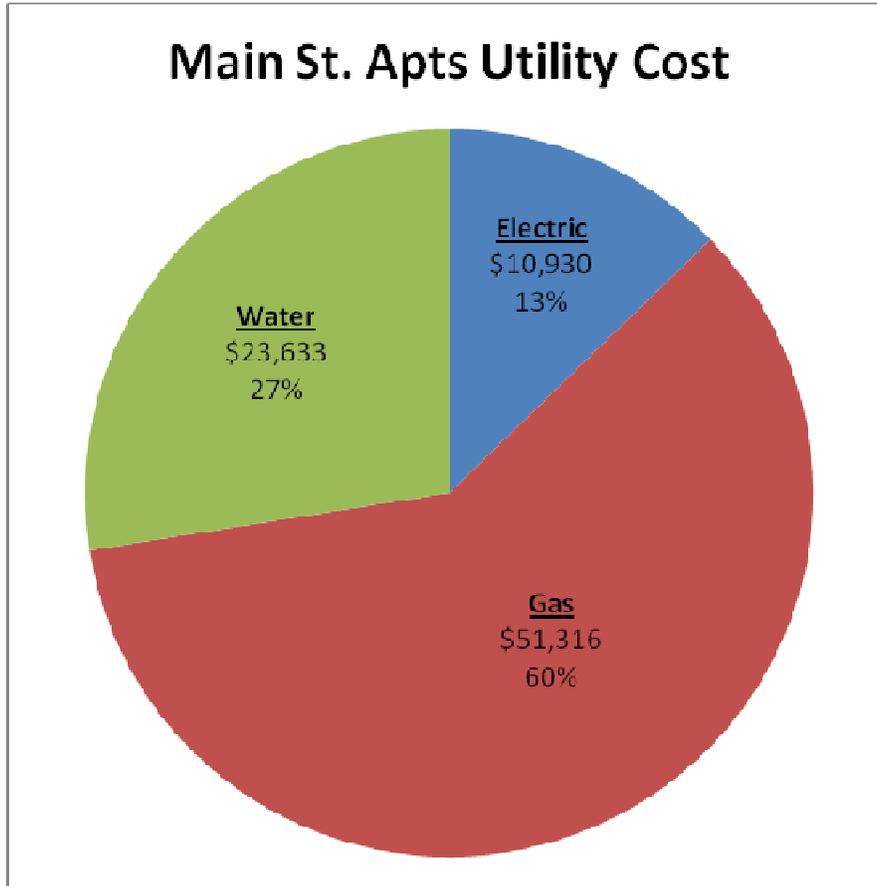
The overall utility costs for the common area services are demonstrated in the pie chart below.
